# TECHNICAL INFORMATION

## Unexplained "SELECT NEUTRAL" Message Display on Instrument Pack

No: 54/01/05/NAS  
 FGN LM205  
 Ref:  
 Issue: 1  
 Date: 18 March 2005

Range Rover (LM) All

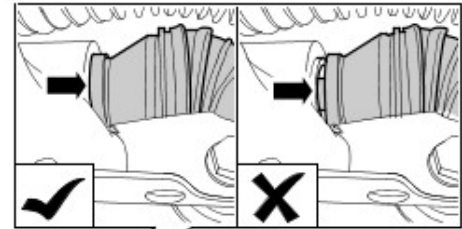
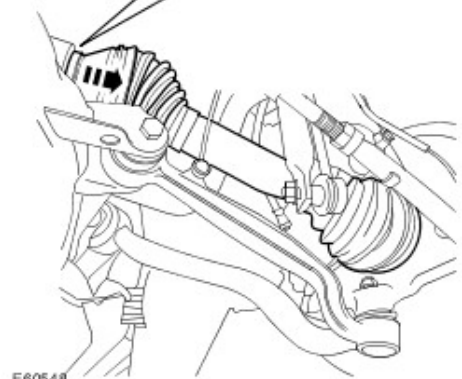
Figure 1

1. Carry out the following steps to verify if disengagement of a driveshaft is the cause of the complaint:
  - Raise the vehicle so the front wheels are freely suspended.
  - Verify that there is no visible gap between the front drive shaft inboard joint and the differential housing on the left-hand side. (Insert "✓" in Figure 1)
  - Verify that there is no visible gap between the front inboard joint and the engine sump on the right-hand side. (Insert "✓" in Figure 1)

**CAUTION:** If the driveshaft retaining circlip is disengaged, manual force alone will be sufficient to move the driveshaft inboard joint from its correct location (Dashed arrow in Figure 1). Tools or levers should NOT be used as this may cause the disengagement of the circlip.

1. If driveshaft disengagement is identified as the root cause, refer to GTR Workshop Manual Section 46.10.01 or 47.10.02 and remove the affected driveshaft.
2. Inspect the driveshaft for damage that could affect retention of the new circlip.
3. If the driveshaft is *not* damaged, perform the following:
  - Install a new retaining circlip and re-install the original driveshaft.
  - Manually check the security of the drive shaft inboard joint into the differential housing.
  - Claim driveshaft remove and replace as a separate warranty repair.
4. If the driveshaft is damaged, perform the following:
  - Install a new driveshaft and circlip.
  - Manually check the security of the drive shaft inboard joint into the differential housing.
  - Claim driveshaft remove and replace as a separate warranty repair.
