Bulletin No.: 06-02-32-007F

Date: August 24, 2009

Subject: Clunk, Knock or Rattle Noise From Front of Vehicle While Driving or Turning Over Bumps at Low Speeds (Diagnose Noise and Perform Outlined Repair)

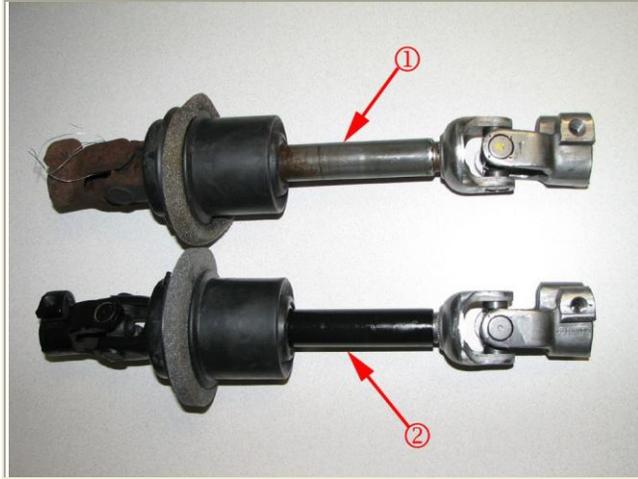
Electric Assist [Power Steering](#)

First Design - Bare Steel Tube (Lube OK)

Second Design - Black Painted (DO NOT Lube)
Hydraulic Assist [Power Steering](#)

In the unlikely event that the source of the noise is identified as a second design shaft with black painted tube, it must be replaced.

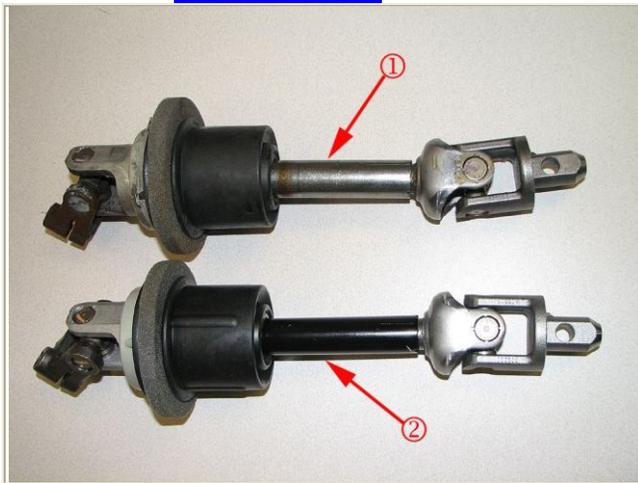
First Design - Bare Steel Tube (Lube OK)

Second Design - Black Painted (DO NOT Lube)

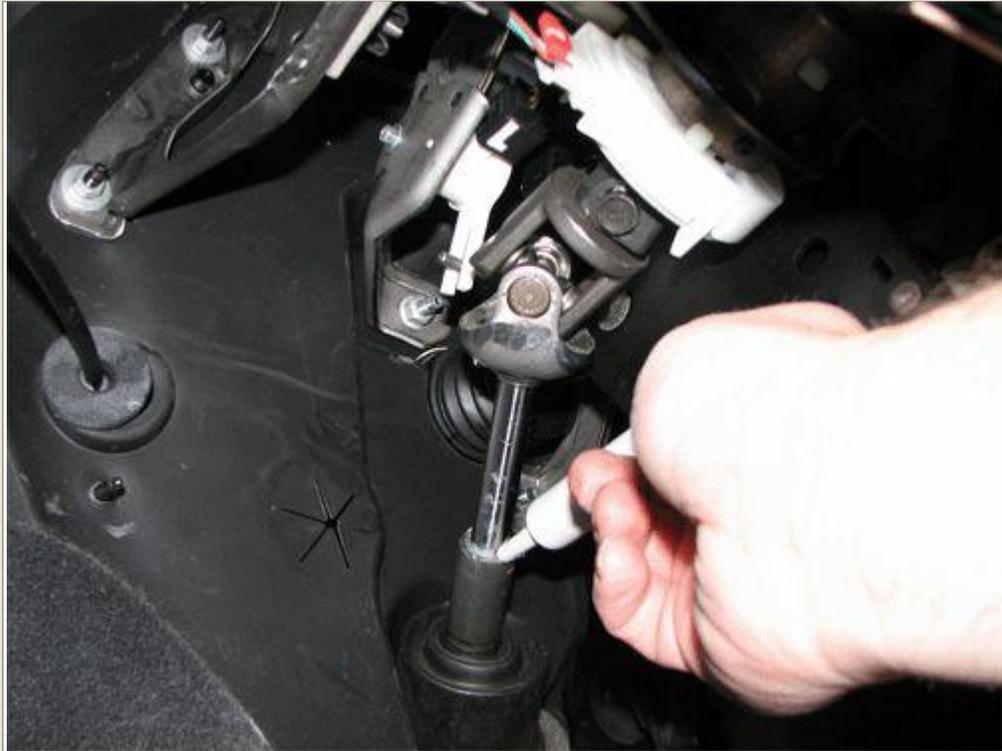
The clunk noise may be caused by a slip/stick condition between the inner and outer components of the intermediate shaft.

4. Extend the intermediate shaft all the way. Using the intermediate shaft grease kit, P/N 26098237, inject the grease into the gap between the inner shaft and the outer shaft as you are collapsing the shaft. This will draw the grease into the shaft.
5. Cycle the shaft up and down several times to distribute the grease.

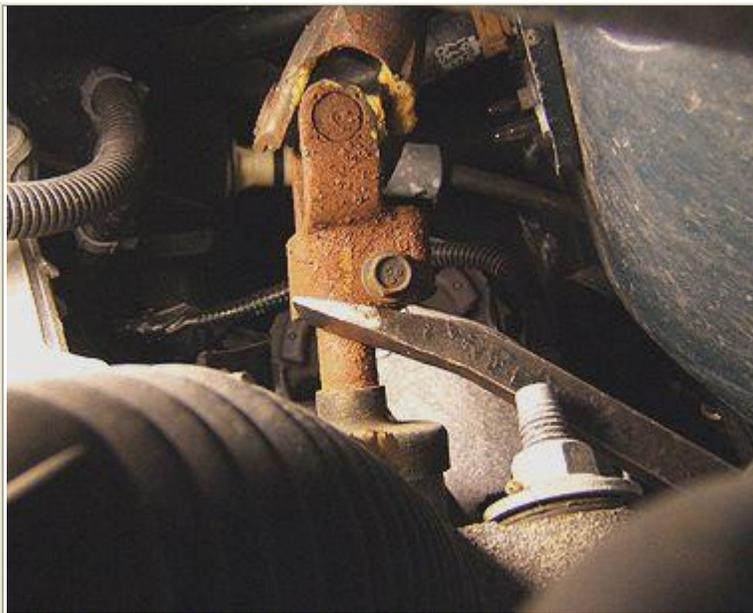
There may be interference between the clamp and the [steering gear](#) input shaft. The clamp is beveled and if forced down on the input shaft too hard, it may cause a loose fit with the intermediate shaft to input shaft joint.

3. Pry the clamp up using a pry bar to position the bolt into the upper part of the groove as shown above. This will position the clamp off the bevel.
4. While keeping the clamp in the upper position, tighten the bolt.
Tighten
Tighten the bolt to 49 Nm (36 lb ft).
5. Verify that the clunk noise is no longer present.

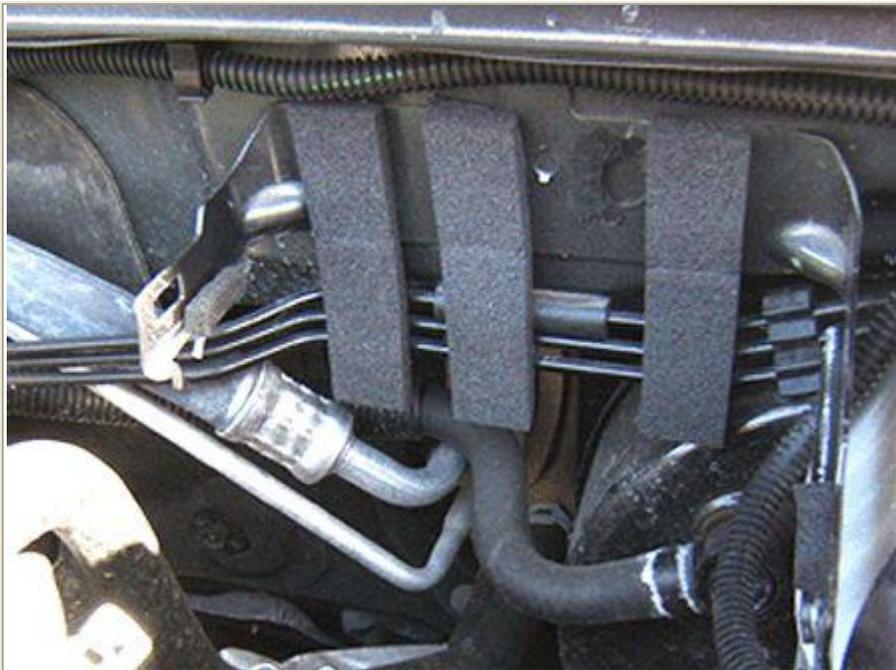
Some customers may comment on a knocking or rattling type noise from the front of the vehicle when driven at low speeds and over bumps. The noise only occurs when the [steering wheel](#) is in the straight ahead position and sounds like the noise is in the left [suspension](#) of the vehicle or directly in front of the driver.

8. Install the three pieces of foam to the attaching bracket starting at the top center inside the bracket and proceed down across the fuel lines, then at the inside of the bracket at the left and right positions of the center piece of foam. Finally, install the last two pieces of foam to the inside bracket at the left and right extended sides behind the retaining holes as shown above.
9. Reposition the radiator surge tank back onto the bracket and seat the two retaining tabs on the tank.
10. Drive the vehicle to verify that the noise is no longer present.
