Wheel Hub (Locking): All Technical Service Bulletins Drivetrain - 4WD Mode Inoperative

TITLE: 4WD Control Vacuum Line

APPLIES TO: Sportage 4WD

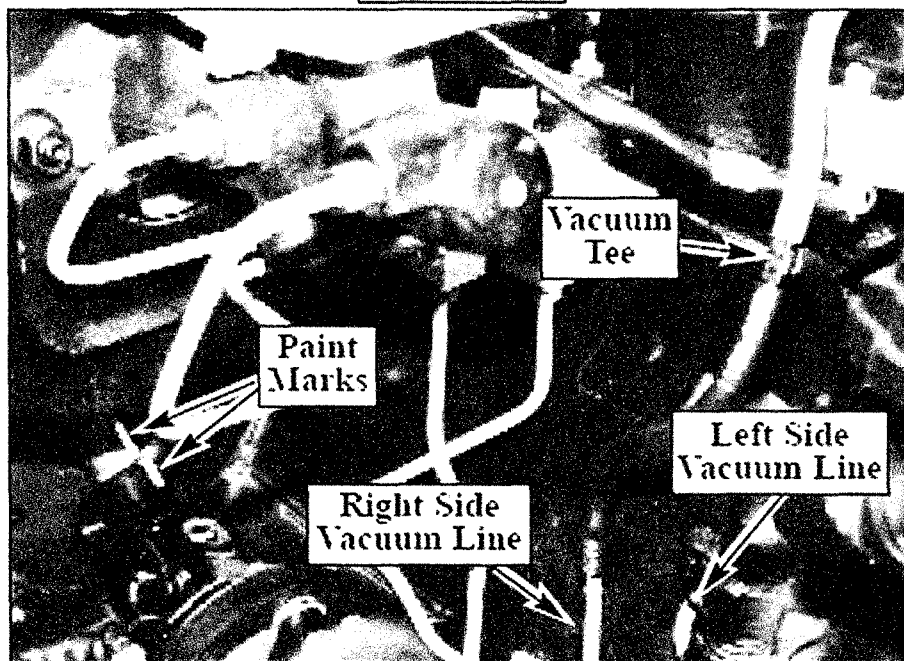
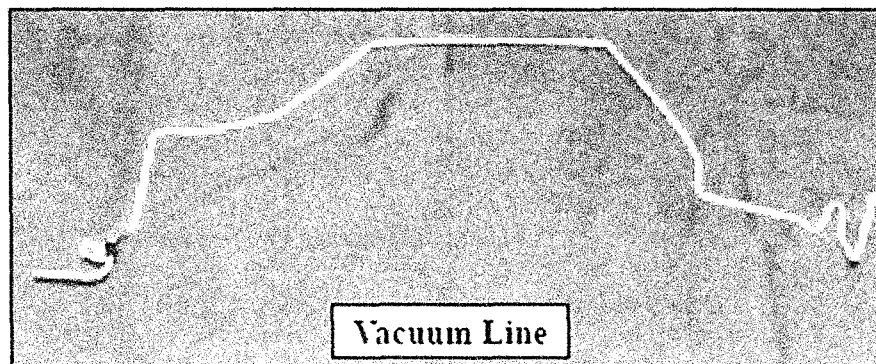
Photo 1

Verify that with 4 wheel drive mode selected, vacuum is present at the T-fitting downstream from the solenoid (see photo). If not, diagnose and

repair as required, otherwise use the following procedure to replace the vacuum lines:
