#01033: Fuel Pump Resistor (Customer Satisfaction Campaign) - (Jul 17, 2001)

Subject: 01033 -- Fuel Pump Resistor

Models: 1997-1998 Buick Regal GS & Pontiac Grand Prix GTP with L67 3.8L V6 Engine (Located in the High Corrosion Provinces of Newfoundland, Nova Scotia, Prince Edward Island, New Brunswick, Quebec and Ontario)

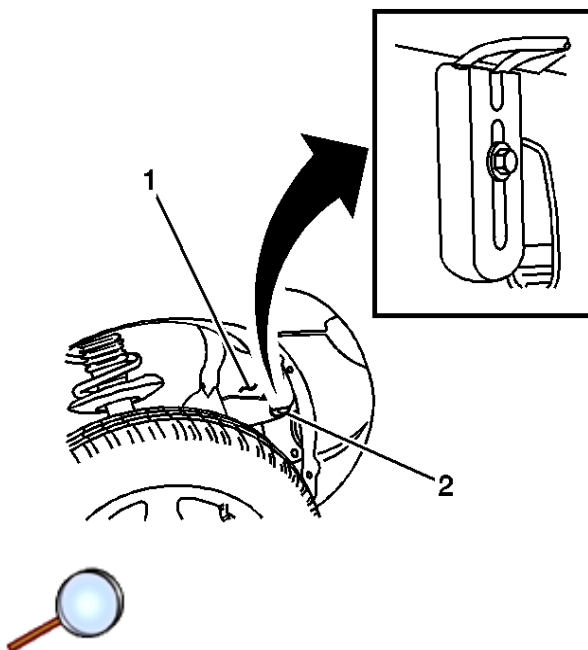
Figure 1

The following are instructions for removing the fuel pump resistor from its original mounting location on the lower right front body rail as shown in Figure 1, and replacing it with a new fuel pump resistor and cover in new location shown in Figure 2. The new location is on the front of dash sheet metal (3) at the rear of the engine compartment, inboard or to the left of the alternator (4). The passenger or right side windshield wiper arm (5) and stop (6) are called out for reference purposed only.

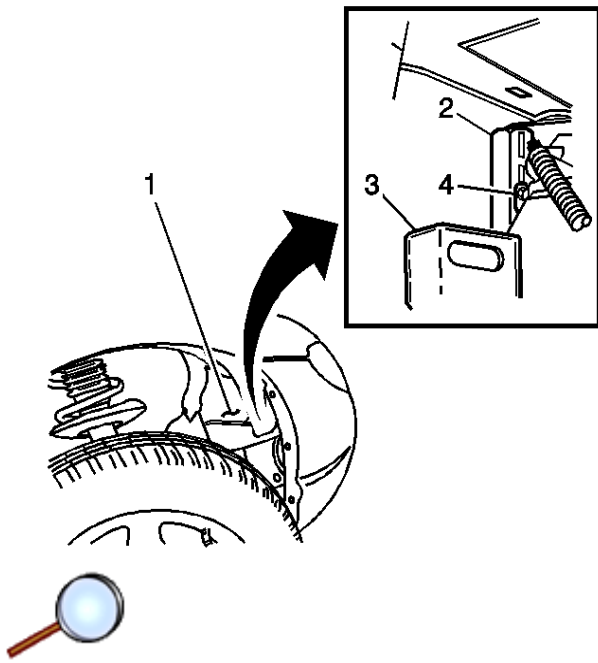
Figure 1

The following are instructions for removing the fuel pump resistor from its original mounting location on the lower right front body rail as shown in Figure 1, and replacing it with a new fuel pump resistor and cover in new location shown in Figure 2. The new location is on the front of dash sheet metal (3) at the rear of the engine compartment, inboard or to the left of the alternator (4). The passenger or right side windshield wiper arm (5) and stop (6) are called out for reference purposed only.

6. Remove the two bolts attaching the windshield washer reservoir to the rear mounting bracket (3) and remove the one bolt attaching the bracket to the body. Refer to Figure 1.
7. From underneath the vehicle, using a 10mm box or open end wrench, remove the bolt (4) that attaches the fuel pump resistor to the body. Refer to Figure 1.
8. Unclip the fuel pump resistor pigtail electrical (2-wire) connector (1) from the sheet metal next to the battery and disconnect the connector.
9. Pull the resistor wiring and connector down and out from under the vehicle. Discard the fuel pump resistor and mounting bolt.
10. Reinstall the windshield washer reservoir rear mounting bracket to the body and install the bolt.
