#01-08-45-005E: Hard/No Start, Fuel Gauge Inop/Fluctuates, SES/Check Engine Light On, ABS Warning Light On, TCS Warning Light On, TCS Activation, Service Traction System Message, All-Wheel Drive Disable Message, DTCs - (Aug 29, 2006)

Subject: Hard/No Start, Fuel Gauge Inoperative/Fluctuates, SES/Check Engine Light On, ABS Warning Light On, TCS Warning Light On, TCS Activation, Service Traction System Message Displayed, All-Wheel Drive Disable Message Displayed, DTCs Set (Repair Connector)

Models: **2002-2006 Buick Rendezvous**
 2005-2007 Buick Terraza
 2000-2005 Chevrolet Venture
 2005-2007 Chevrolet Uplander
 2000-2004 Oldsmobile Silhouette
 2000-2005 Pontiac Montana
 2001-2005 Pontiac Aztek
 2005-2007 Pontiac Montana SV6
 2005-2007 Saturn Relay

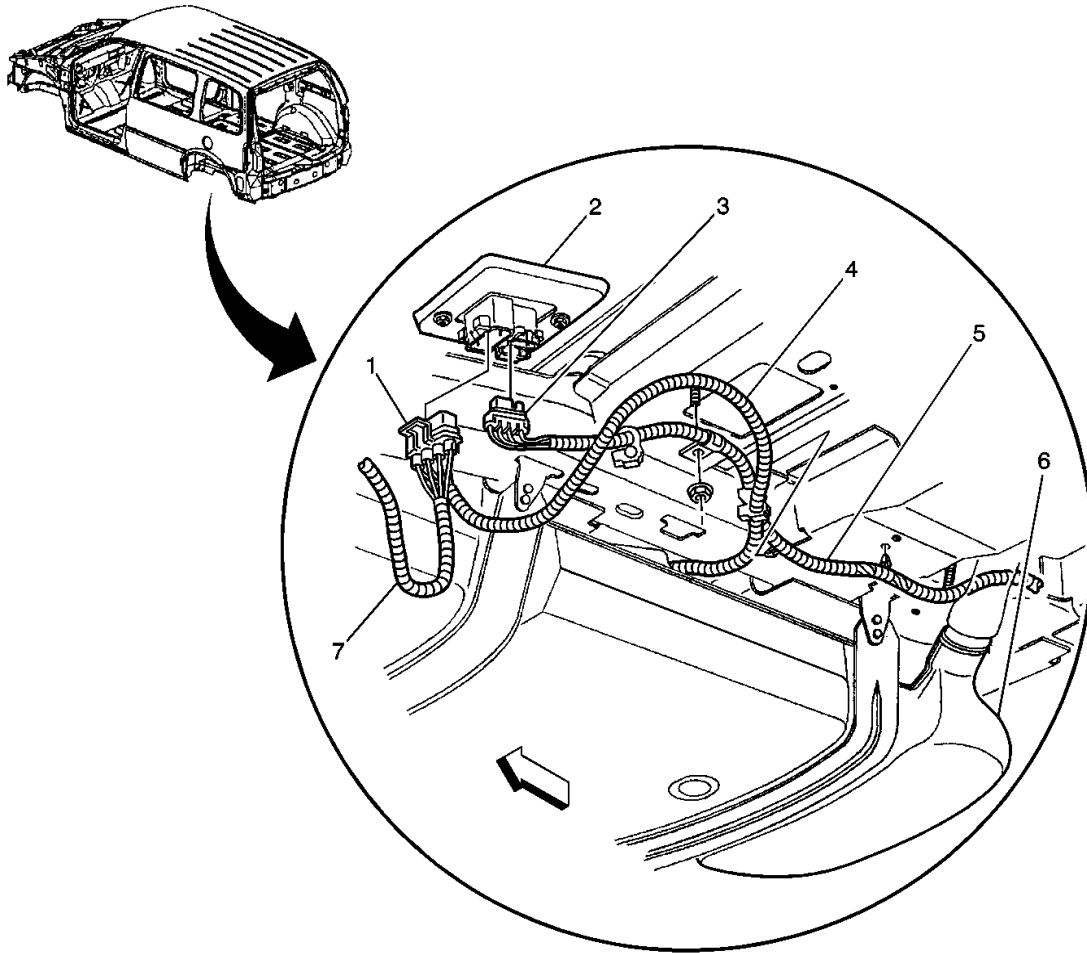
Underneath Vehicle, Behind Driver Seat

This condition may be due to water leaking into the interior of the vehicle, and/or spread terminals, at connector C305 that is located on the floor to the rear of the driver's seat. This connector is not sealed from the inside of the vehicle and water may enter the connector causing the terminals to become corroded. Also, the female terminals of the connector may have become spread apart causing an intermittent poor connection.

- Inspect the terminals at connector C305 for corrosion or spreading before replacing the fuel module or resistor card kit. Terminals can be accessed from underneath the vehicle.
- Do not attempt to repair any spread female terminals as this will result in a return repair. The female terminal must be replaced.
- If the terminals show signs of corrosion, determine the source of the water leak first and repair the water leak before repairing the terminals in connector C305. Refer to Corporate Service Bulletin Number 01-01-38-009A to determine a potential source for water in the vehicle interior.

Repair any corroded and/or spread female terminals in connector C305. Refer to Repairing Connector Terminals in the Wiring Systems sub-section of the appropriate service information.
