**Subject: Intermittent Slow to Cool HVAC Performance Concerns in High Ambient Temperatures and/or High Humidity Conditions After Start Up, Especially at Low Engine Speeds (Install New Engine Cooling Fan Clutch)**

**Models: 2004-2005 Buick Rainier  
2002-2005 Chevrolet TrailBlazer Models  
2002-2005 GMC Envoy Models  
2002-2004 Oldsmobile Bravada  
2005 Saab 9-7X**

**Subject: HVAC System Inoperative For A Drive Cycle, Poor HVAC System Performance In High Ambient Temperatures (Update HVAC Control Module Software)**

**Subject:        Air Conditioning (A/C) Inoperative/Intermittent, A/C Blows Warm Air (Replace A/C Low Pressure Cycling Switch)**

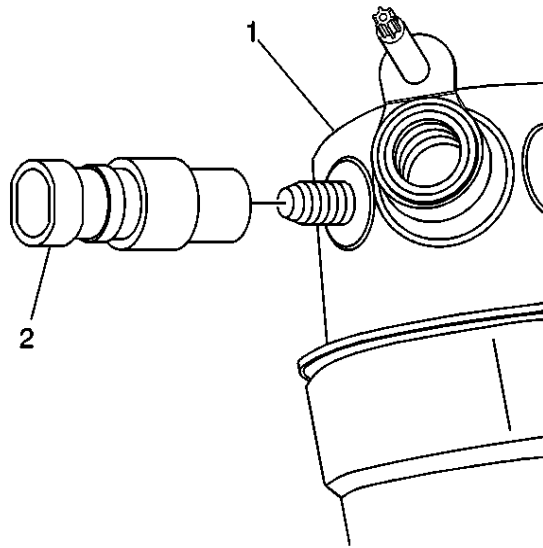
An intermittent inoperative (open) A/C low pressure cycling switch may be the cause. This is an intermittent condition and temperatures may play a critical role if the vehicle is in the failed mode or operating as designed.

18. If the compressor is not operating as designed, tap on the low pressure cycling switch (2) with a small hand tool. The compressor should start operating correctly.
19. If the compressor does not operate correctly after tapping on the low pressure cycling switch (2), disconnect the switch and jumper the lower pressure cycling switch connector with a fused jumper. If the compressor still does not operate properly, refer to HVAC Compressor Clutch Does Not Engage diagnostic in SI.

20. If the compressor does operate correctly after tapping on the switch or jumping the low pressure cycling switch connector, replace the low pressure cycling switch (2), P/N 89040362. Refer to Air Conditioning (A/C) Low Pressure Switch Replacement in SI.
21. Perform the Air Conditioning (A/C) System Performance Test in SI.
22. Disconnect the J 43600 ACR 2000 Air Conditioning Service Center.
23. Remove the fender covers and close the hood.
