**Freightliner  
Service Bulletin**

## General Information

## Checking the Engine Harness Connections

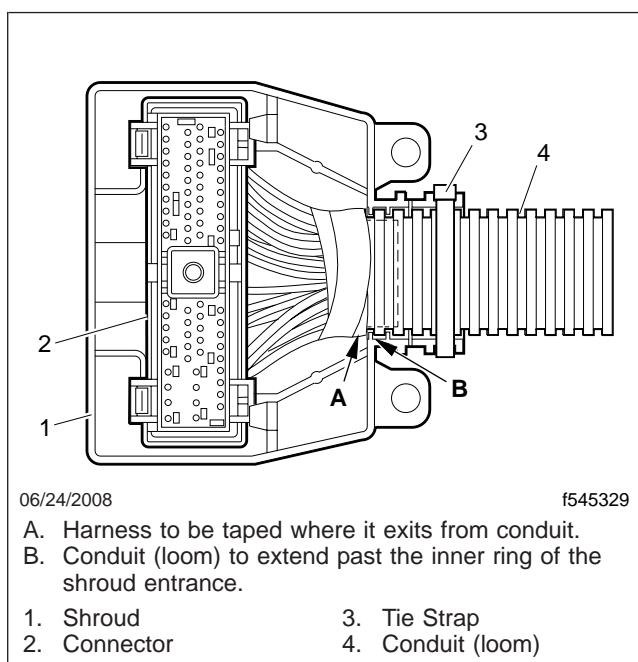
**Fig. 1, ECU Connector and Shroud**

On vehicles equipped with Detroit Diesel Series 60 engines and DDEC V, incorrect harness installation can result in damage to the wiring, which can cause erroneous fault codes to be displayed, as well as gauge fluctuations. Most of this damage is caused by the wiring rubbing against the ridges at the base of the shroud.

- 6.5 Make sure each conduit (loom) extends all the way into the rear of the shroud. It must extend past the inner ring of the shroud inlet. Most of the damage to the wiring has been from the wires rubbing against the ridges at the base of the shroud.

- 6.1 Check for damage to or breakage of the individual wires. Remove the connectors from the shrouds and, if applicable, make the necessary wiring repairs.
- 6.2 With the connectors removed from the shrouds, check all unused cavities in each connector for missing plugs. Install new plugs if needed.
- 6.3 Check that all the wires have seals to keep out moisture. Install new seals if needed.
