### A/T - SMG Transmission, Clutch Does Not Engage

SI B 23 04 02

SMG Transmission; Clutch Does Not Engage

E46 M3 Coupe and Convertible with SMG from start of production to 07/02.

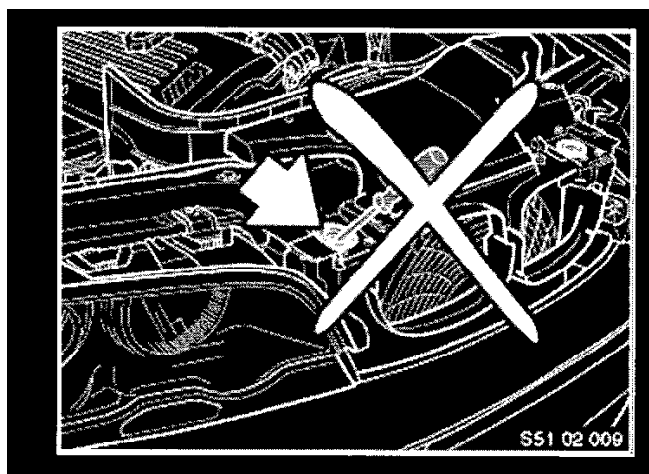
The micro switch failure could be caused by damage during assembly, or incorrect adjustment. Another possible cause is improper handling of the micro switches during a workshop visit. In the workshop, care should be taken to ensure that no tools are pushed into the lower hood latch assemblies as the switching element on the micro switch could be bent or damaged.

The opening must not be used for holding tools!

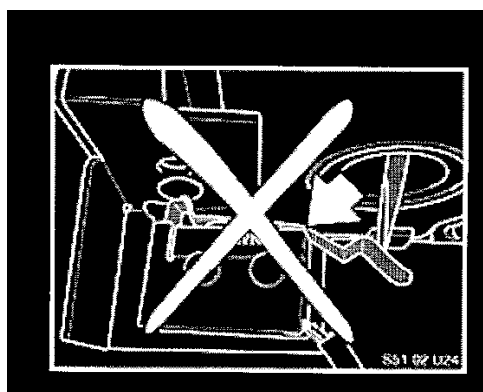
During diagnosis, the switching element of the lower must not be pressed too hard (illustration shows internal view of hood latch assembly).

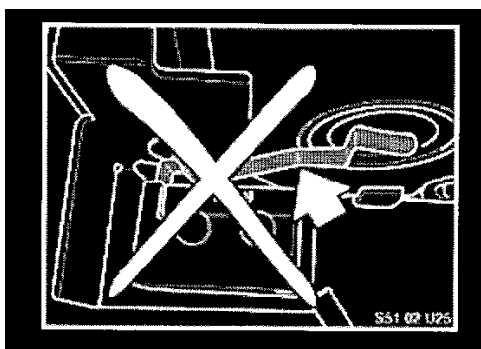
Illustration shows a bent switching element

Replace faulty lower/lower hood latch assembly, or correct hood adjustment as needed. Adjustment procedure and specifications can be found in Repair Instructions 41 61 014.
