NUMBER: 18-031-03

4.0L Rough Engine Idle After Restart Following A Hot Soak

This bulletin involves the installation of a fuel injector insulator sleeve.

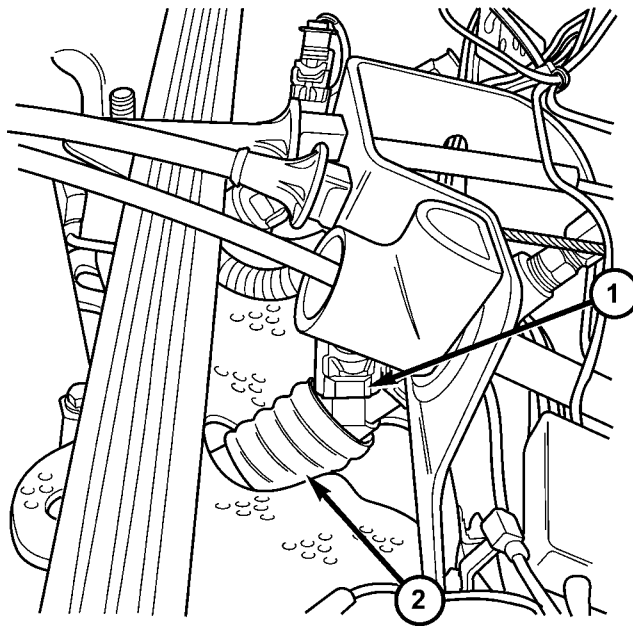
Fig. 1 SLEEVE INSTALLATION

This condition may be caused by heat from the exhaust manifold that following engine shut down migrates to the area around injector #3 and causes fuel vapor to form within the injector. This in turn may cause a momentary misfire of cylinder #3 until the fuel vapor is cleared of injector #3. The insulator sleeve lowers the injector #3 temperature to a point below which the fuel will not normally vaporize.

- 1 - # 3 INJECTOR
- 2 - INSTALLED SLEEVE

1. Cut insulator sleeve, p/n 56028371AA, to make two (2) insulator sleeves about 25-30 mm (1 in.) in length.
2. Install one sleeve around injector #3, with the slit on the upward facing side of the injector. Install the other sleeve with the slit on the downward facing side of the injector.
3. Confirm sleeve is flush to intake manifold surface around injector.
4. Check injector #3 wire and ensure that the injector is rotated to a 2 o'clock position (from driver's side of vehicle).
