Applies To: 1999-03 3.2 TL – ALL
2001-03 3.2 CL – ALL

Blower Motor Does Not Work

(Supersedes 06-006, dated February 14, 2006 to update the information with the black bars)

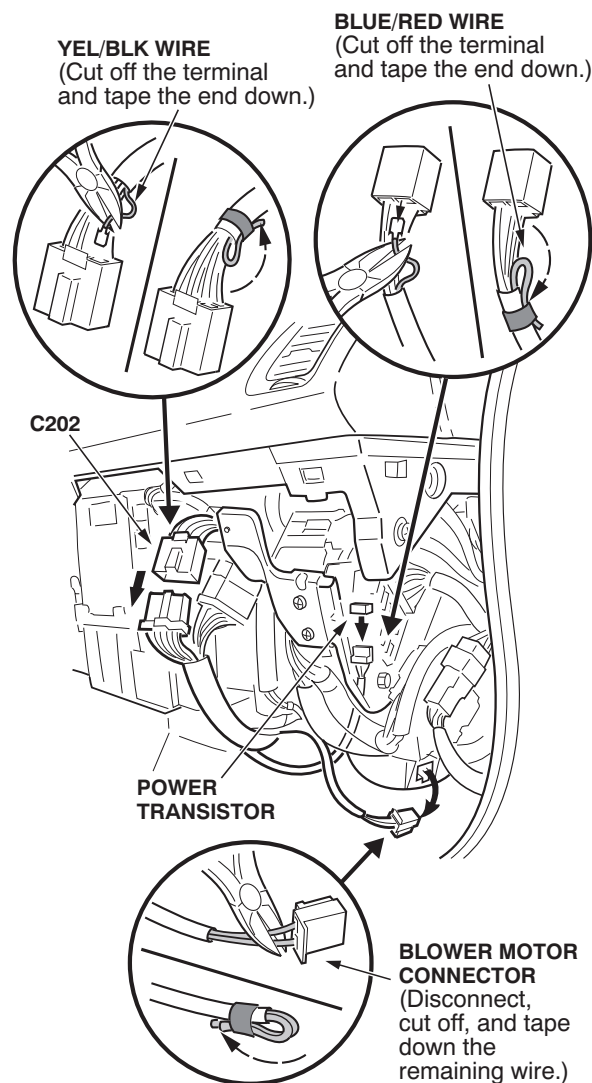
- Disconnect the brown 7P connector (C202) from the main harness. Remove the YEL/BLK wire terminal from cavity 3 of connector C202. Cut off the terminal, and tape the remaining end of the wire to the harness.
