Applies To: **1999-03 3.2 TL – ALL**
2001-03 3.2 CL – ALL

Blower Motor Does Not Work

(Supersedes 06-006, dated February 14, 2006 to update the information with the black bars)

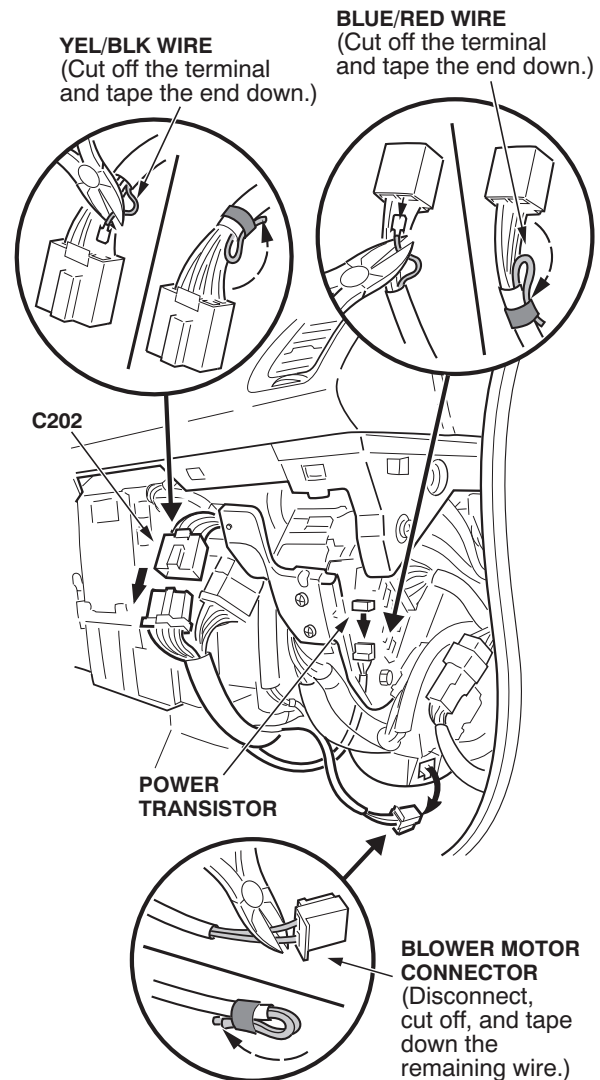
2. Disconnect the brown 7P connector (C202) from the main harness. Remove the YEL/BLK wire terminal from cavity 3 of connector C202. Cut off the terminal, and tape the remaining end of the wire to the harness.

NOTE: If necessary, refer to the terminal replacement section of the appropriate ETM for how to properly remove a terminal from a connector.

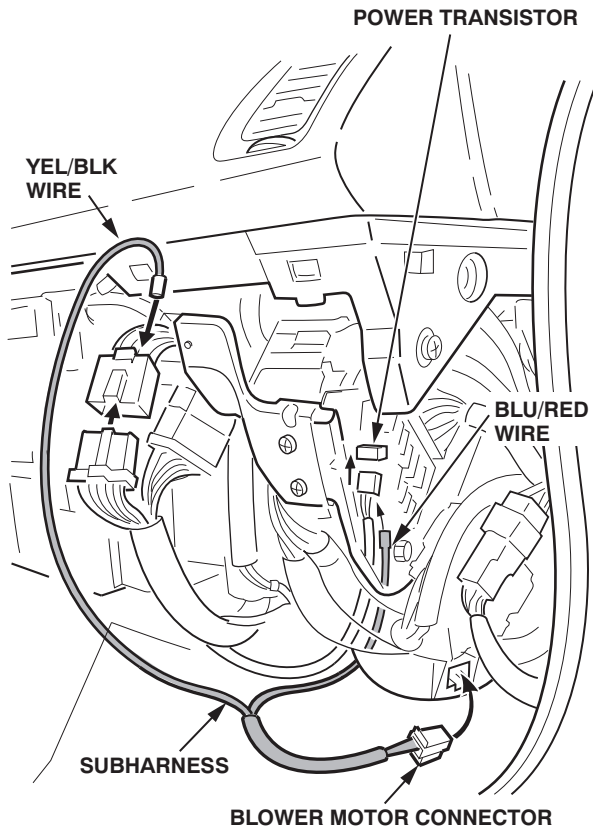
Poor connection at the blower motor caused by tension on the wiring harness.

3. Disconnect the 2P blower motor connector, cut off the connector, and tape the remaining ends of the wires to the pigtail. Then tape the pigtail to the main harness.
4. Disconnect the white 5P connector from the power transistor. Remove the BLU/RED wire terminal from cavity 4 of the power transistor connector. Cut off the terminal, and tape the remaining end of the wire to the harness.
5. Take the subharness, and insert the YEL/BLK wire terminal into cavity 3 of connector C202 and insert the BLU/RED wire terminal into cavity 4 of the power transistor connector. Tape both wires to the existing harness. Route the harness so there is no tension on the blower motor connector.

6. Reconnect connector C202 and the power transistor connector, then connect the 2P connector on the new subharness to the blower motor.
7. Verify the blower motor operates properly at all speeds.
8. Reinstall the glove box and cover.
