Applies To: 1999-03 3.2 TL – ALL
2001-03 3.2 CL – ALL

April 27, 2006

Blower Motor Does Not Work

(Supersedes 06-006, dated February 14, 2006 to update the information with the black bars)

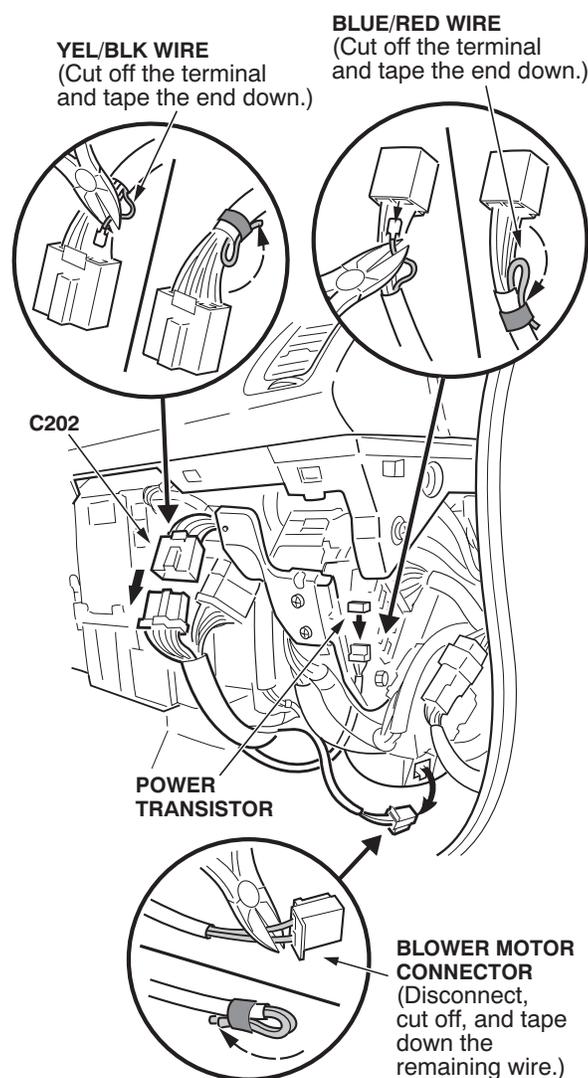
Poor connection at the blower motor caused by tension on the wiring harness.

2. Disconnect the brown 7P connector (C202) from the main harness. Remove the YEL/BLK wire terminal from cavity 3 of connector C202. Cut off the terminal, and tape the remaining end of the wire to the harness.
