Powertrain Management: All Technical Service Bulletins

Spark Plug Wire - Miss/Buck/Spark Knock

94-4-10

1987-94 BRONCO, E-150, E-250, F-150, F-250

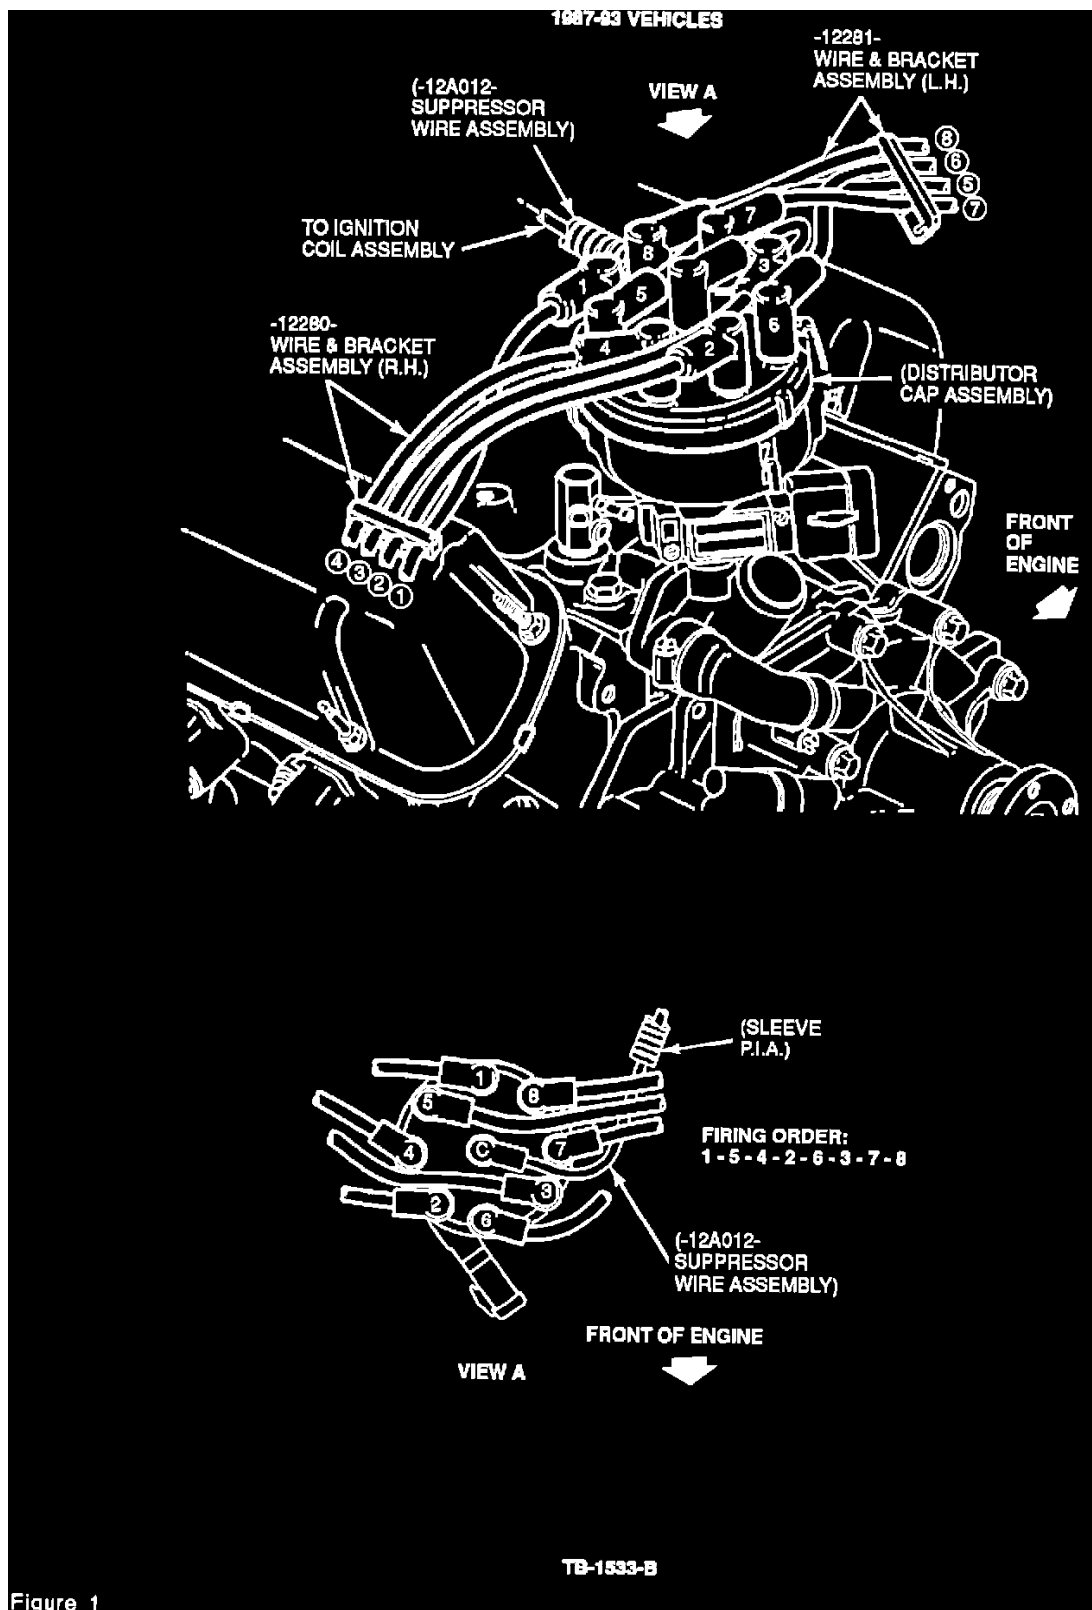
Figure 1

- ^ The firing order for 1987-1993 vehicles is 1-5-4-2-6-3-7-8. If # 7 and # 8, or # 2 and # 4 spark plug wires are routed next to each other at the separation bracket, an induction crossfire condition can occur.
- ^ The firing order for 1994 vehicles is 1-3-7-2-6-5-4-8. On these vehicles the # 1 and # 3, or # 5 and # 6 spark plug wires must be separated to eliminate the possibility of an induction crossfire.
- ^ To eliminate the possibility of the coil wire becoming disconnected, route the coil wire under the spark plug wires at the distributor cap.

1. Inspect the routing of the spark plug wires. Refer to Figures 1 and 2.
2. Make any spark plug wiring corrections as required.
