Engine Controls - Spark Knock/MIL ON/ DTC P0332 Set

Bulletin No.: 02-06-04-023A

Date: June, 2002

Audible Spark Knock (Detonation), MIL Illuminated, DTC P0332 Set (Replace Rear Bank Knock Sensor and RTV Area Around Sensor)

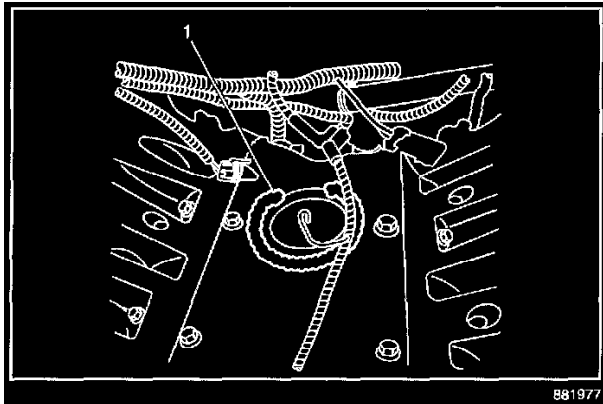
This condition may be the result of corrosion of the rear bank knock sensor due to water intrusion into the sensor cavity. This condition is more apparent on vehicles in which customers frequently wash the engine compartment.

3. Remove the rear bank knock sensor.
4. Install the new rear bank knock sensor.
Tighten
Tighten the knock sensor to 20 N.m (15 lb ft).
5. Install the wiring harness assembly to the knock sensor.

6. Apply a bead of RTV silicone sealant approximately 9 mm (3/8 in) wide and 6 mm (1/4 in) high along the outside edge of the ridge on the engine block valley cover around the rear bank knock sensor. DO NOT form a complete circle. Leave the rear section open as shown.
7. From the underside of the intake manifold, completely remove the rear intake manifold seal (foam material).
8. Install the intake manifold. Refer to the Intake Manifold Replacement procedure in the Engine Controls sub-section of the appropriate Service Manual.
