## TECHNICAL

Bulletin No.: 06-06-01-014C

Date: June 25, 2008

L36, L67, L26, L32, LA1, LX9, MN7, M15 Ticking or Knocking Type Noise Coming From Engine or Transmission Area (Replace Flexplate and Torque Converter)

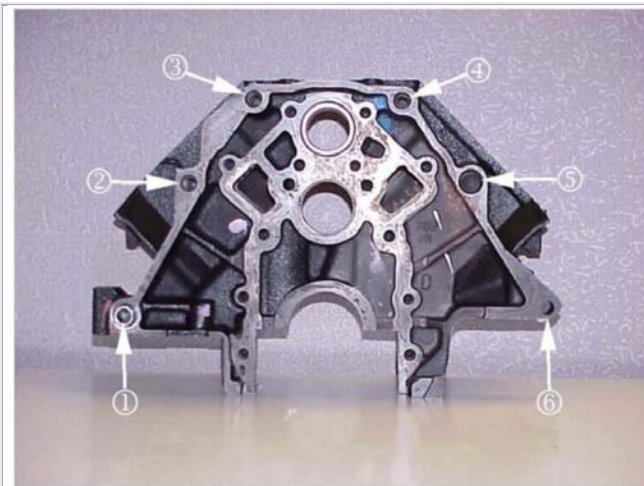
- 9 o'clock Dowel Pin
- 10 o'clock Bolt Hole
- 11 o'clock Bolt Hole
- 1 o'clock Bolt Hole
- 2 o'clock Bolt Hole
- 3 o'clock Bolt Hole

11. Inspect for the presence of alignment dowel pins (bushings) in the rear of the engine block. There should be one dowel pin at the 9 o'clock position and one at the 2 o'clock position.
12. Inspect the dowel pins for the following:
  - ^ Verify that the pins are tight in the block.
  - ^ Verify that the pins have a smooth finish and are not bent. Dowels should be straight in the hole and not mushroomed or angled.
  - ^ Verify that the pins are installed deep enough in the block so as not to bottom out in the transmission housing when installed.

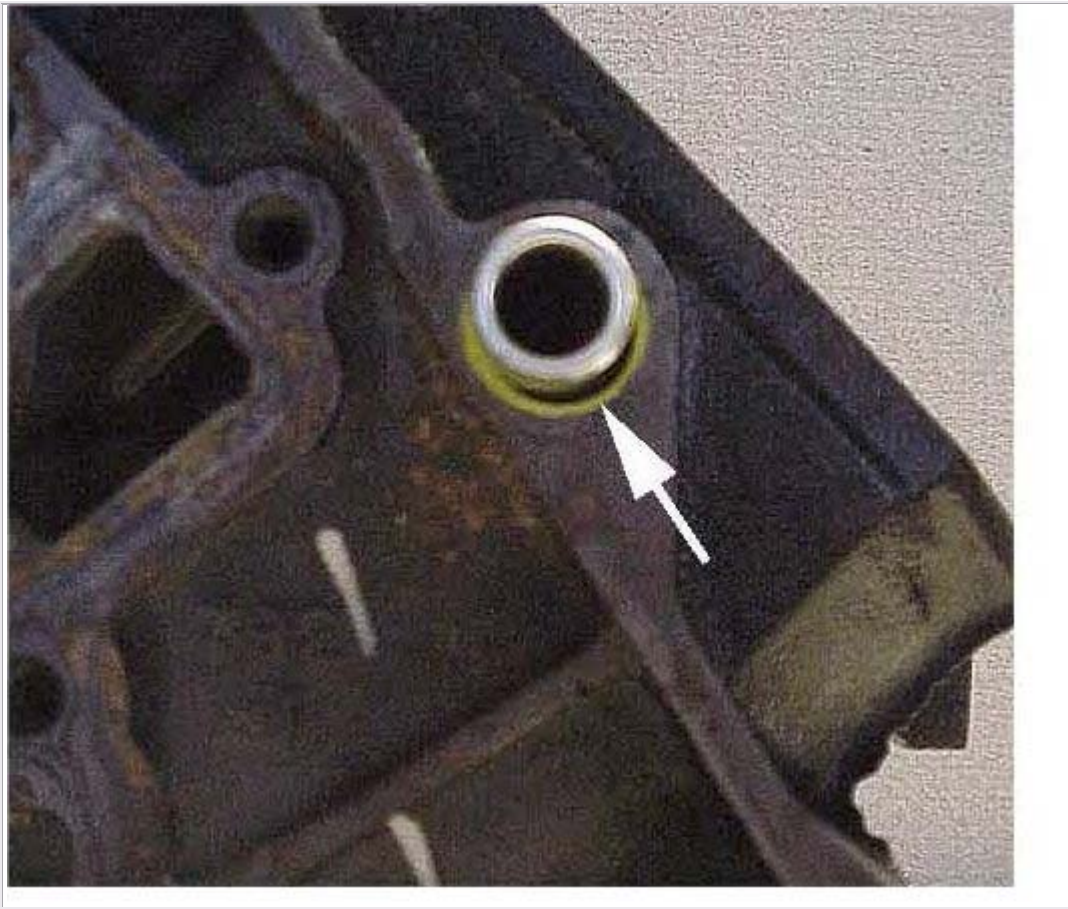
13. Inspect the dowel pin at the 2 o'clock position for the condition shown by the arrow in the above picture. Note that the gap may appear on ANY SIDE of the dowel pin. If this condition is found, the complete engine assembly must be replaced.
14. If the condition shown in the above illustration is NOT found, use clamping type pliers (vise grips) to remove the dowel pin from the 2 o'clock position.

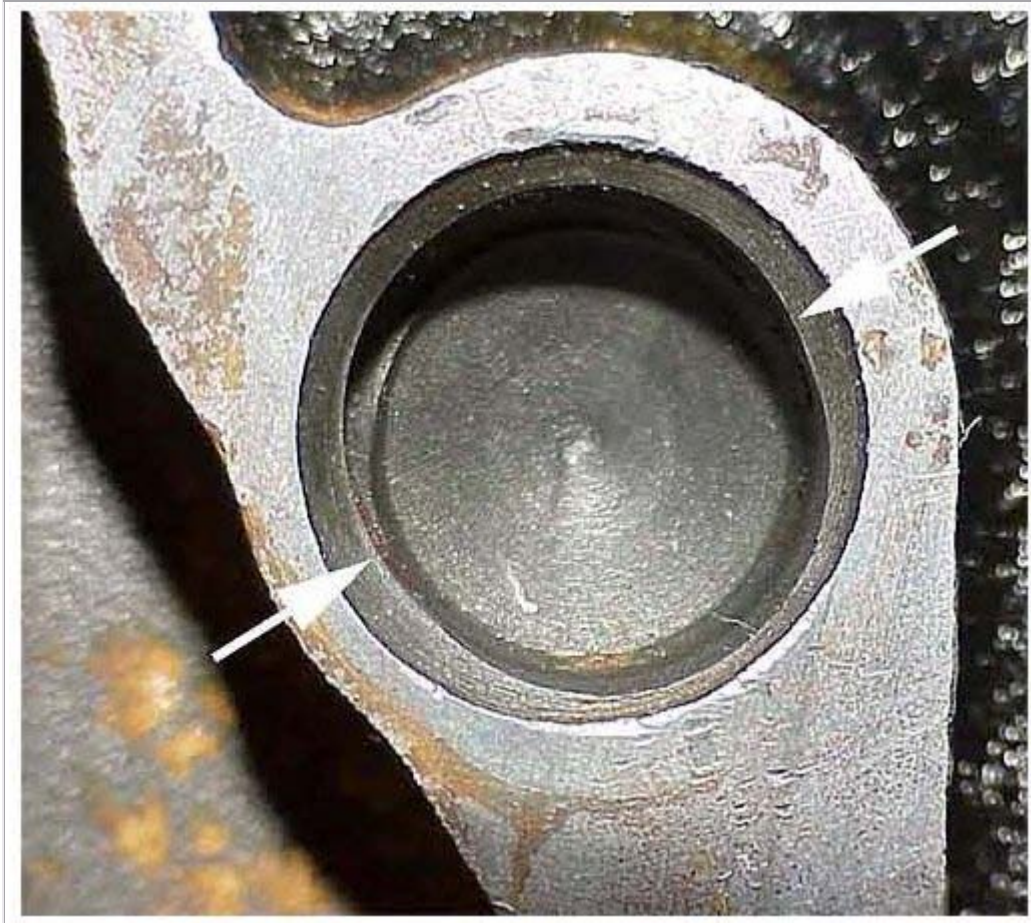
15. Inspect the hole in the block at the 2 o'clock position for an out-of-round condition.
  - ^ If the hole is mis-machined or drilled, it will appear somewhat egg or peanut-shaped. You may be able to feel flatness on the sides of the hole as shown by the arrows in the above illustration. If this condition is found, the complete engine assembly must be replaced.
  - ^ If the hole at the 2 o'clock position is NOT out-of-round, proceed to the next step.
16. Install a NEW dowel pin in the block at the 2 o'clock position.
