2005 GMC Truck Envoy 2WD L6-4.2L VIN S

Instruments - Erratic Speedometer Operation

Bulletin No.: 07-08-49-027

Erratic Speedometer Operation Or Speedometer Needle Shakes Above 60 mph (96 km/h) (Repair Poor Connection At Ground G108)

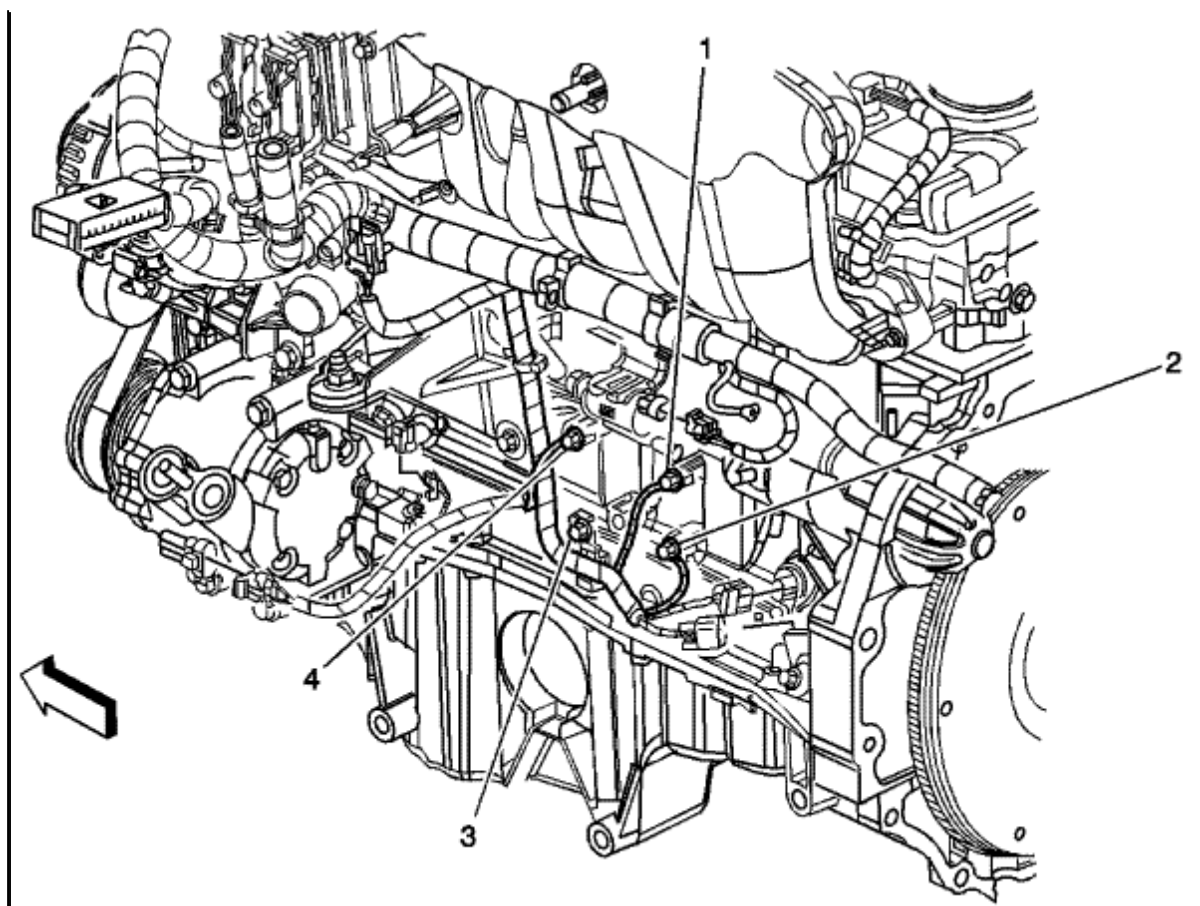
Some customers may comment on erratic operation of the speedometer. Others may comment that the speedometer needle shakes above 96 km/h (60 mph).

This condition may be caused by a loose or poor connection at Powertrain Control Module/[Engine Control Module](#) (PCM/ECM) ground G108.

Technicians are to inspect and repair ground G108 as necessary. Refer to callout 1 in the illustration above for the location of G108. Refer to the Testing for Intermittent Conditions and Poor Connections and the Wiring Repair procedures in SI for more information.
