ITB02-022

April 15, 2002

2000-2002 G20 MIL "ON" REAR O2 SENSOR DTC P0138/P0139/P0140

APPLIED VEHICLES: 2000-2002 G20 (P11)

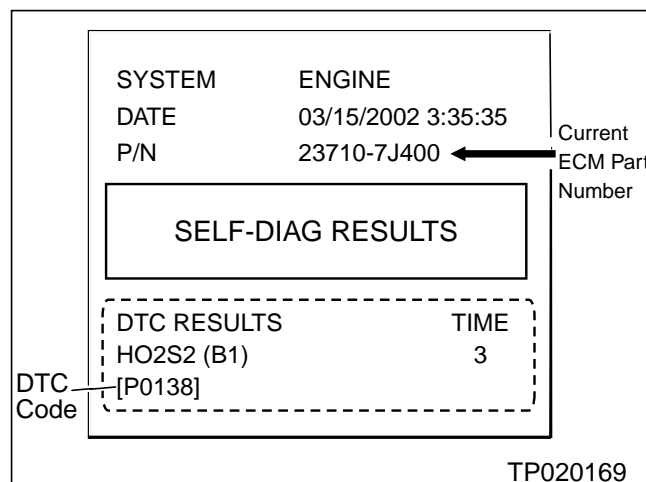
1. Determine which DTC code is stored in the vehicle's ECM by performing CONSULT-II Self-Diagnosis.
2. Print out the Self-Diagnosis results for use in **ECM Part Number Check**, below. See Figure 1 for an example of the CONSULT-II Self-Diagnosis printout.

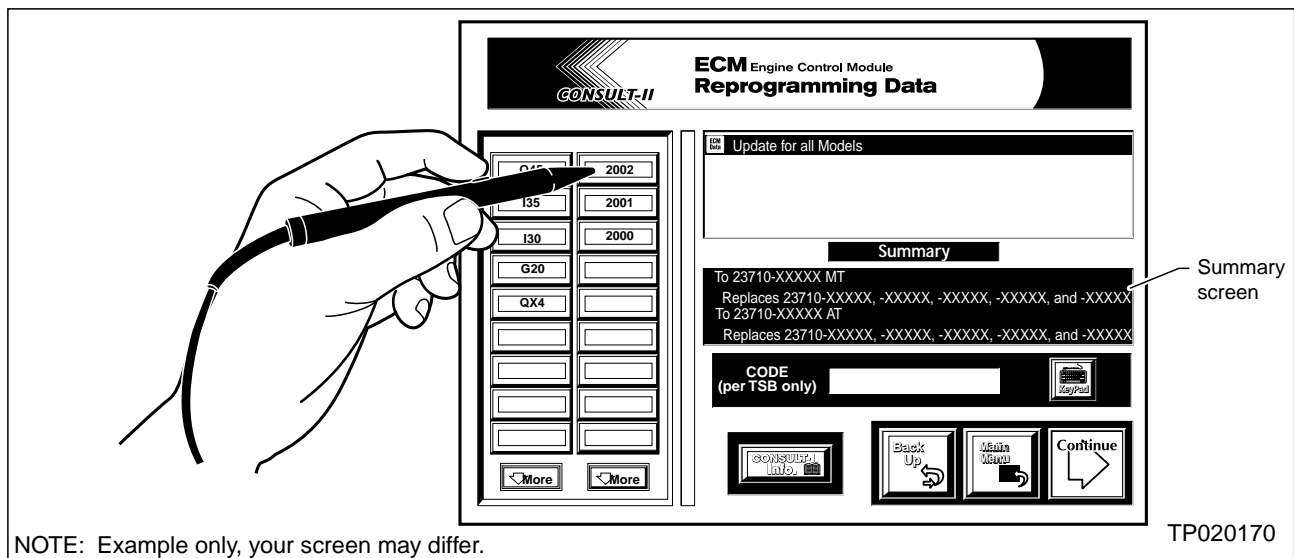
Figure 2

- Select model and model year for the applied vehicle (i.e. G20, 2002).

- B) Locate the vehicle configuration you made note of in step 1A on page 2 (i.e. M/T) from those listed in the upper right ECM data description window.
- C) Make a note of the "To" number listed in the "ECM Reprogramming Data" Summary screen.
NOTE: The "To" number will read: 23710-XXXXX.
- D) Press "Continue" and follow directions to perform data download from ASIST to CONSULT-II.
- E) When reprogramming from CONSULT-II, select the "To" number that you made note of in step C, above.
2. Go to and perform **Replacing the Rear Oxygen Sensor** (below).
