SERVICE BULLETIN

Classification: BR06-011b	Reference: NTB07-016b	Date: July 10, 2007
------------------------------	--------------------------	------------------------

2004 – 2007 MAXIMA; ABS ACTIVATES WITH NORMAL BRAKING / ABS WARNING LAMP IS ON

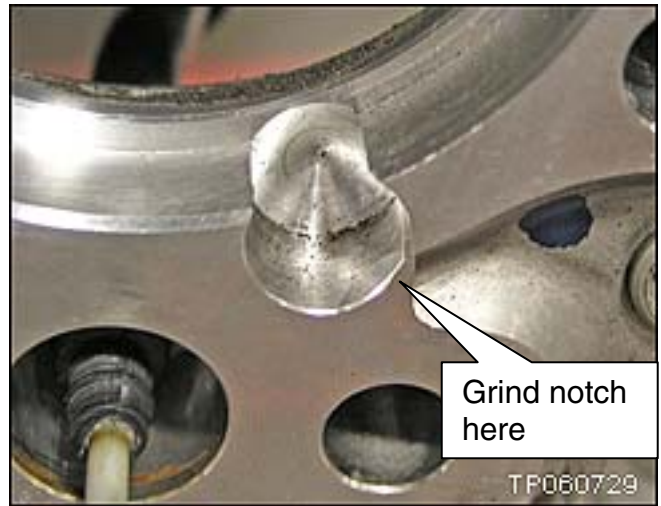
Figure 7

Before grinding

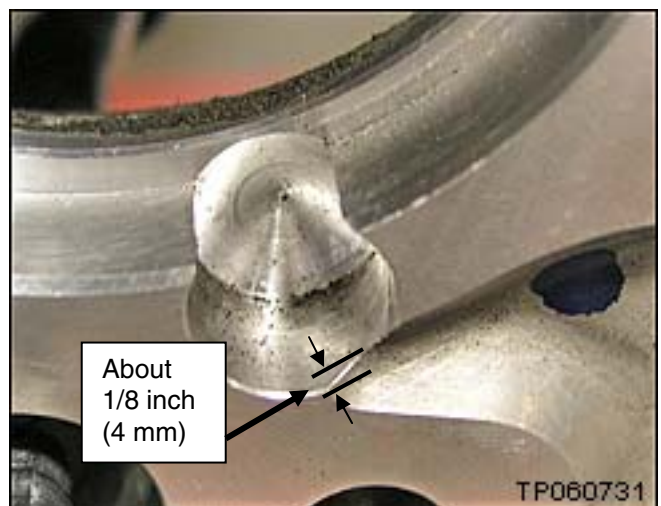
Figure 8

After grinding
