SERVICE BULLETIN

Classification: EL00-001	Reference: NTB00-019	Date: February 21, 2000
-----------------------------	-------------------------	----------------------------

1999 MAXIMA NO START AND SECURITY LAMP ON WITH NATS DTC "ID DISCORD, IMM-ECM"

APPLIED VEHICLE(S): 1999 Maxima (A32)

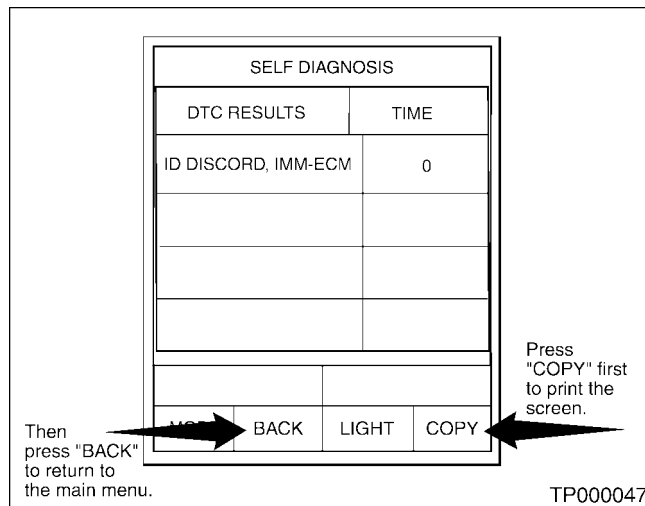
Figure 6

6. Confirm Self Diagnosis Result "ID DISCORD, IMM-ECM" displayed on the CONSULT-II screen (see Figure 6).

- If the vehicle's ECM # is in the **ORIGINAL ECM #** column, replace the ECM with the applicable **UPDATED PART #** from the Parts Information section of this bulletin, then proceed to step 16.
- If the vehicle's ECM # is in the **UPDATED ECM #** column, replace the NATS Immobilizer Control Unit (IMMU) with the one from the Parts Information section of this bulletin, then proceed to step 16.

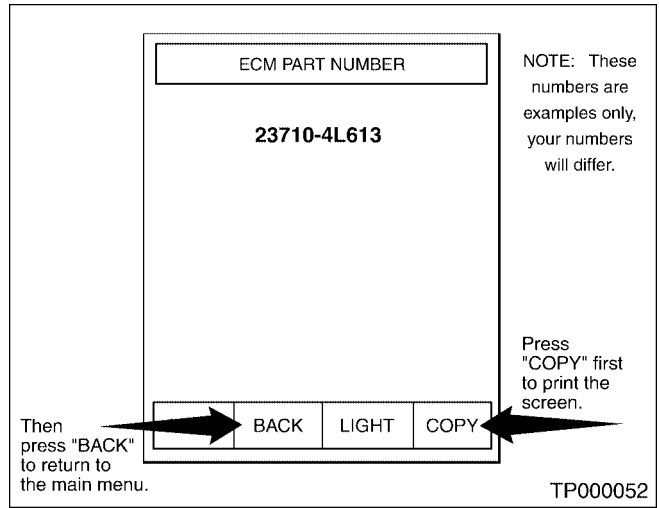
Figure 12

13. Press "COPY" to print the ECM PART NUMBER screen (see Figure 12). **Attach this printout to the repair order.** Then press "BACK" to return to the CONSULT-II main menu.
