Printable View (109 KB)	
<b>TSB</b> <b>09-20-14</b>	<ul style="list-style-type: none"> <li>• <b>UN-COMMANDED TCC APPLY ON THE 1-2 SHIFT CAUSING PERCEPTION OF HESITATION AND/OR LACK OF POWER DURING SHIFT</b></li> </ul>
Publication Date: October 5, 2009

- FORD:** 2005-2010 Crown Victoria  
2005-2006 Expedition  
2005-2010 E-150, E-250, E-350, F-150
- LINCOLN:** 2005-2010 Town Car  
2006-2008 Mark LT
- MERCURY:** 2005-2010 Grand Marquis

This article supersedes TSB 6-22-7 to update the Issue Statement, vehicle model years and model line covered.

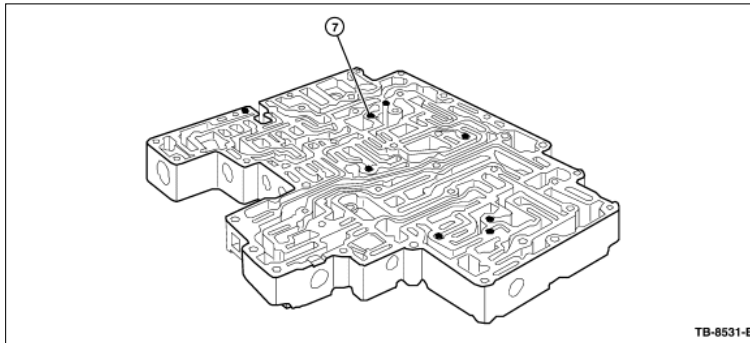
Figure 1 - Article 09-20-14

Some 2005-2010 vehicles equipped with a 4R70/75E-W transmission may experience an un-commanded torque converter clutch (TCC) apply or TCC partial apply immediately after the 1-2 shift. This may result in the perception that the vehicle lacks power or that the transmission is up-shifting too early. Additional symptoms of uncommanded TCC apply when coming to a stop (before the 2-1 downshift is commanded), are engine stalling or lugging when engaging manual 2nd while at a stop and code P1742 may be present in continuous memory. However, the vehicle should operate normally in park, reverse, neutral and manual 1st gear.

1. Monitor (TCC %) solenoid command state - duty cycle and (TC SLIP ACT) torque converter clutch slippage - RPM, while in 2nd, 3rd or 4th gear with a TCC % reading 0.
  - a. If TCC % = 0 and TC SLIP ACT = less than 20 RPM then inspect the number 7 check ball in the main control valve body for damage. Replace as required following the appropriate Workshop Manual (WSM) under Disassembly and Assembly of Subassemblies - Main Control Valve Body. (Figure 1)

- b. If you receive any other reading, this procedure does not apply; follow normal diagnostic procedures as outlined in the appropriate WSM.
