Printable View (109 KB)	
<b>TSB</b> <b>09-20-14</b>	<ul style="list-style-type: none"> <li>• <b>UN-COMMANDED TCC APPLY ON THE 1-2 SHIFT CAUSING PERCEPTION OF HESITATION AND/OR LACK OF POWER DURING SHIFT</b></li> </ul>
Publication Date: October 5, 2009

- FORD:** 2005-2010 Crown Victoria  
2005-2006 Expedition  
2005-2010 E-150, E-250, E-350, F-150
- LINCOLN:** 2005-2010 Town Car  
2006-2008 Mark LT
- MERCURY:** 2005-2010 Grand Marquis

This article supersedes TSB 6-22-7 to update the Issue Statement, vehicle model years and model line covered.

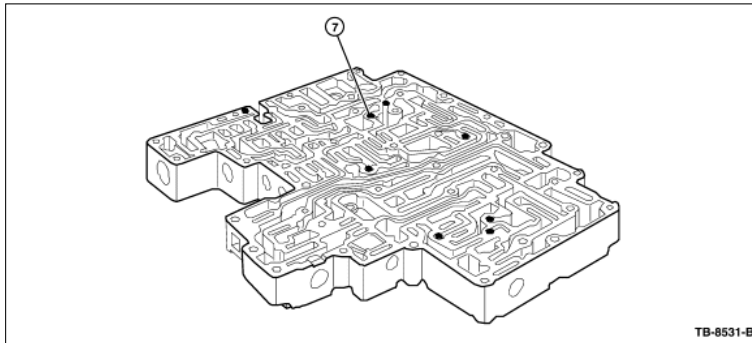
Figure 1 - Article 09-20-14

Some 2005-2010 vehicles equipped with a 4R70/75E-W transmission may experience an un-commanded torque converter clutch (TCC) apply or TCC partial apply immediately after the 1-2 shift. This may result in the perception that the vehicle lacks power or that the transmission is up-shifting too early. Additional symptoms of uncommanded TCC apply when coming to a stop (before the 2-1 downshift is commanded), are engine stalling or lugging when engaging manual 2nd while at a stop and code P1742 may be present in continuous memory. However, the vehicle should operate normally in park, reverse, neutral and manual 1st gear.

1. Monitor (TCC %) solenoid command state - duty cycle and (TC SLIP ACT) torque converter clutch slippage - RPM, while in 2nd, 3rd or 4th gear with a TCC % reading 0.
  - a. If TCC % = 0 and TC SLIP ACT = less than 20 RPM then inspect the number 7 check ball in the main control valve body for damage. Replace as required following the appropriate Workshop Manual (WSM) under Disassembly and Assembly of Subassemblies - Main Control Valve Body. (Figure 1)

**NOTE:** THIS PROCEDURE IS PERFORMED IN 2ND GEAR AUTO (NOT MANUAL 2). MONITOR (TC SLIP ACT) AFTER THE POWERTRAIN CONTROL MODULE (PCM) COMMANDS 2ND GEAR AND BEFORE THE VEHICLE SPEED SENSOR (VSS) READS 35 MPH (56 KM/H).
