#02-06-01-016A: (MIL) Service Engine Soon Telltale Illuminated With DTCs P0171 and/or P0174 (Retorque Intake Manifold Vacuum Chamber Bolts, Install Vacuum Chamber Springs) - (Mar 24, 2003)

Models: 2002-2003 Saturn VUE -- Built Up To and Including VIN Breakpoint 3S854417
with 3.0L, V6 Engine (VIN B -- RPO L81)

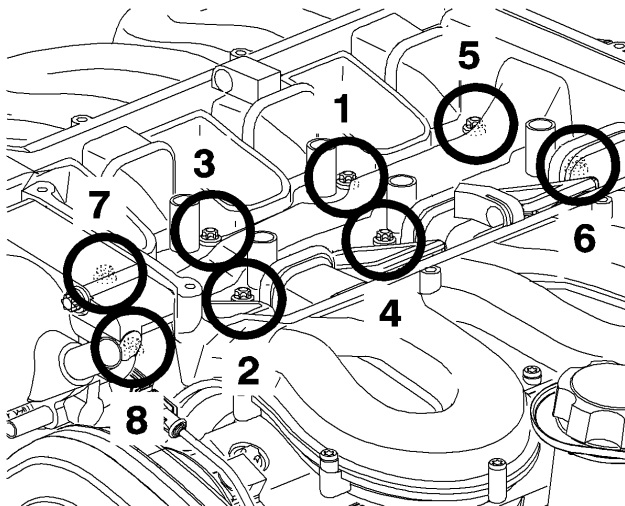
This condition may be caused by insufficient torque on the intake manifold vacuum chamber bolts. Under deceleration, enough vacuum can be created inside the intake manifold to lift the vacuum chamber off it's seal creating an intermittent vacuum leak.

5. Remove 16 (10 around outside, 6 on inside) intake manifold top cover bolts and cover.
6. Remove vacuum chamber and apply Loctite™ 242, P/N 21485277 (in Canada, P/N 12345382), or equivalent, to the bolts and reinstall.
