TSB 08-5-6

ENGINE VIBRATION AT IDLE

FORD:
2000-2008 Focus

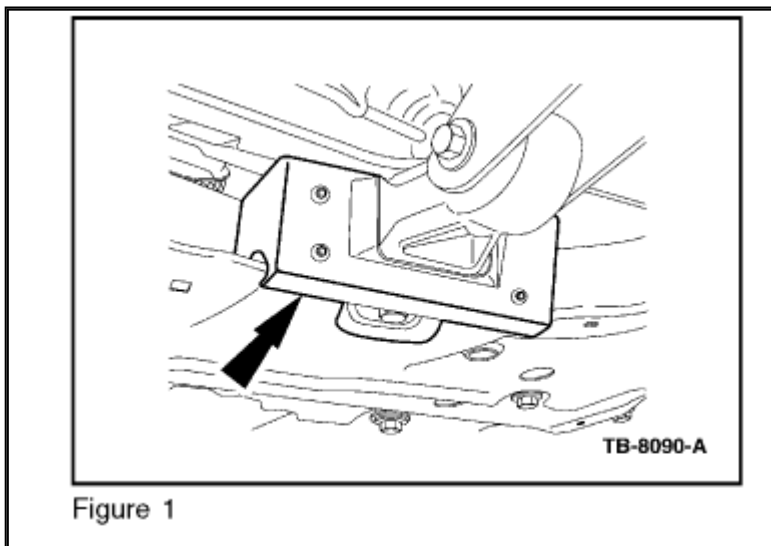
Some 2000-2008 Focus vehicles may exhibit an excessive engine vibration at idle, most noticeable when the transmission is engaged in reverse. This condition may be caused by small stones, road debris, ice or snow packed/lodged in the rear engine roll restrictor.

4. Install service shield (Figure 1).
5. Reinstall roll restrictor attachment bolt and torque to 35 lb-ft (47 N.m).
