Group:
TRANSAXLE

Number:
05-40-006-1

Models:
1999 - Sonata
2001 - Elantra, Santa FE & XG,
2003 - Tiburon
2005 - Tucson

Subject:
ATA SOLENOID DIAGNOSTIC CODES P0740, P0741, P0742, P0743, P0746, P0748,
P0750, P0755, P0760, P0765, P0770

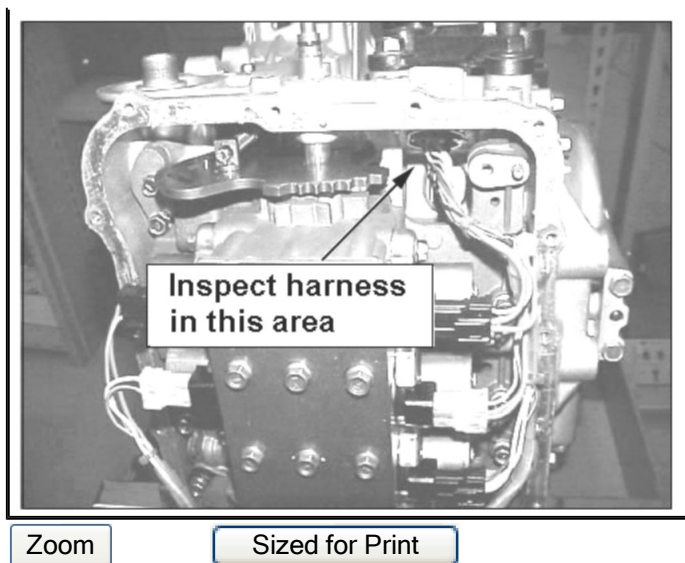
3. Visually check the wiring harness between the [TCM](#) and transaxle for a damaged wire or a short circuit to ground. Disconnect the connectors to the solenoids at the transaxle and the PCM/TCM and check for a bent pin or a pin not fully inserted into the connector. If so, repair or replace the [ECM](#) control harness, P/N 914XX-XXXXX.

MODEL	Harness P/N
2001~ Elantra, Santa Fe, 2003 Tiburon, Tucson, 1999~2005 Sonata	46307-39050
2006~ Sonata	46308-3A550
XG300/350	46308-39550

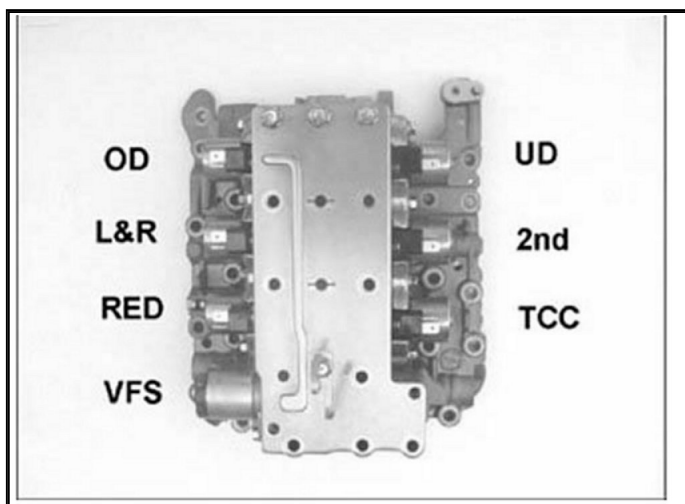
- ^ P0743 - TCC solenoid open/short
- ^ P0746 - VFS solenoid performance
- ^ P0748 - VFS solenoid open/short
- ^ P0750 - LR solenoid open/short
- ^ P0755 - UD solenoid open/short
- ^ P0760 - 2nd solenoid open/short
- ^ P0765 - OD solenoid open/short
- ^ P0770 - RED solenoid open/short

10. Refer to the DTC recorded in Step 1 and replace the related solenoid according to the diagram shown. Tighten the bolts to 4-5 lb.ft (50-70 kg.cm). Go to Step 11.
