Front Windows Bind or Have Come Out of the Run Channel

(Supersedes 97-021, dated February 22, 2000)

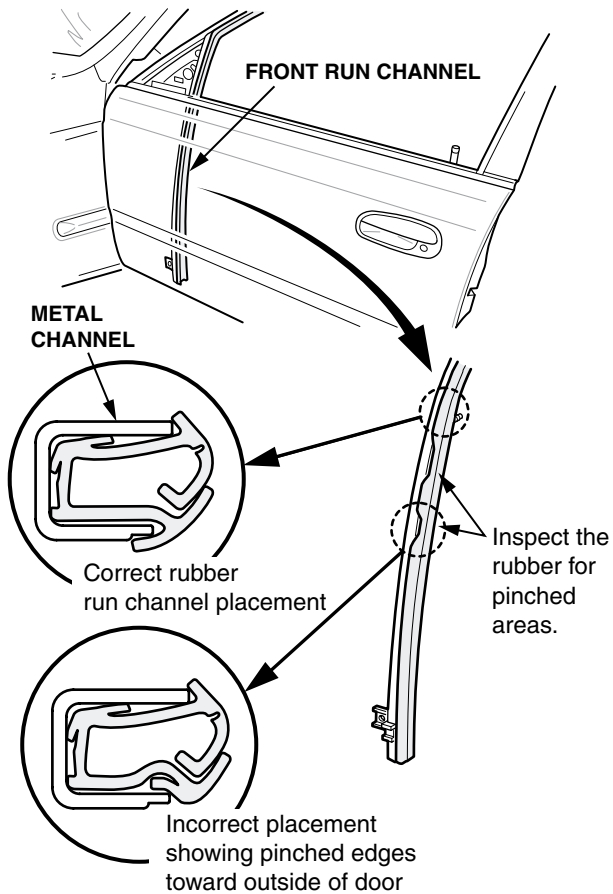
9. Inspect the glass run channel:

- If the run channel is not sitting in the window channels properly, reinstall it.
- If the run channel is damaged, replace it. Refer to section 20 of the appropriate service manual.
- If the run channel is sitting in the window channels properly, go to step 10.
