2007 Chevrolet Suburban C1500

Excessive Engine Oil Consumption (Verify Condition, Inspect Valve Stems, Replace Cylinder Heads if Necessary)

TECHNICAL SERVICE BULLETIN

Reference Number(s): 07-06-01-007B, Date of Issue: July 18, 2008

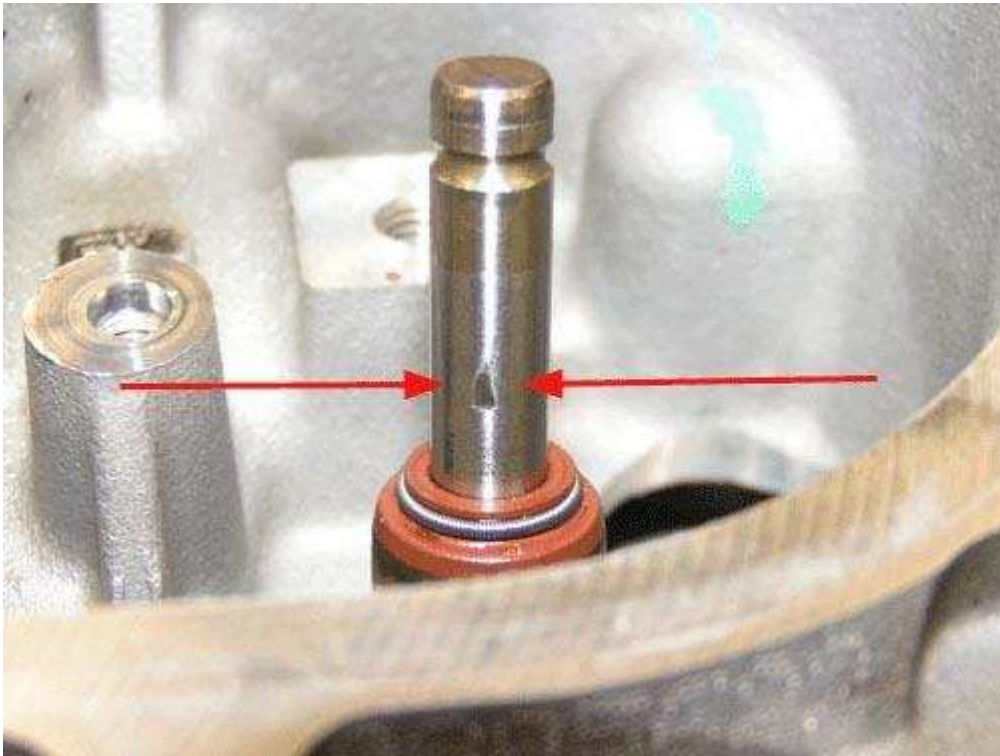
The engine oil consumption may be caused by a nick in the valve stem.

Fig. 1: View Of Nicked Valve Stem (1 Of 2)
Courtesy of GENERAL MOTORS CORP.

A valve stem nick can be in any 360 degree area due to rotation, so each valve stem must be examined carefully.

If the engine oil consumption is excessive, and a nicked valve stem has been found, the cylinder heads will need to be replaced. The cylinder heads will be serviced as an assembly (the head will be complete with valves and springs) and shipped to the dealer by the Warranty Parts Center (WPC). The dealer will have to order the necessary parts/gaskets to complete the cylinder heads remove and replace. Refer to the Cylinder Head Replacement procedures in the applicable Engine Mechanical sub-section.

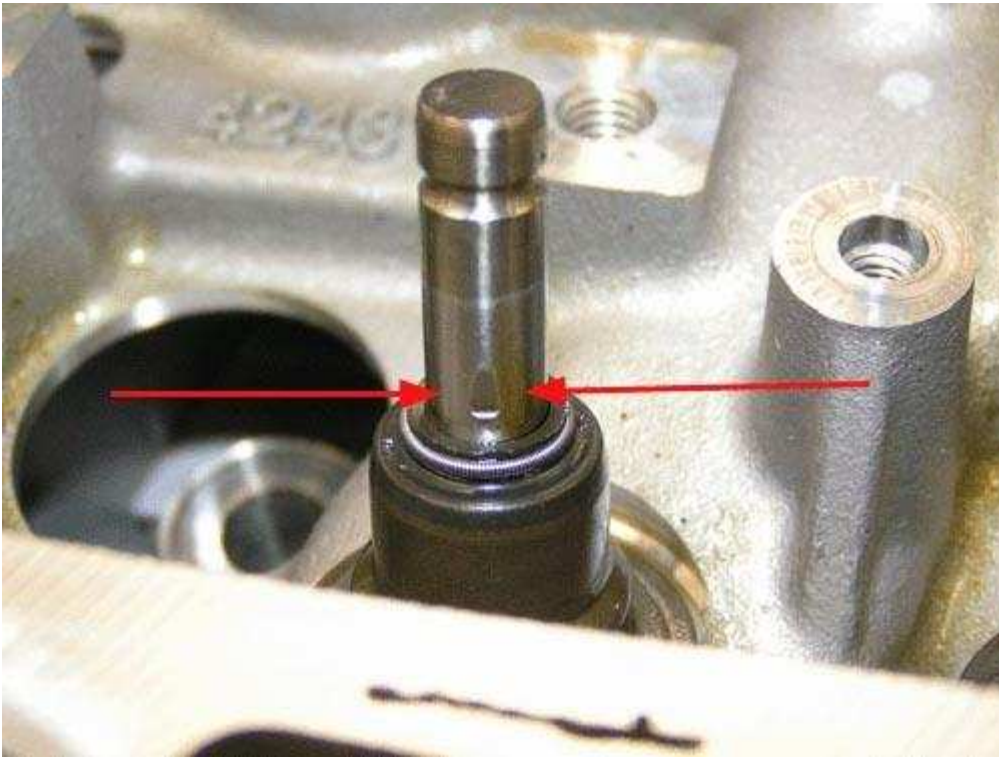
Fig. 2: View Of Nicked Valve Stem (2 Of 2)
Courtesy of GENERAL MOTORS CORP.
