## TECHNICAL SERVICE BULLETIN

Reference Number(s): NTB02-044, Date of Issue: April 10, 2002

NISSAN: 2000-2002 Frontier, Xterra

COOLANT LEAK FROM INTAKE MANIFOLD WATER OUTLET

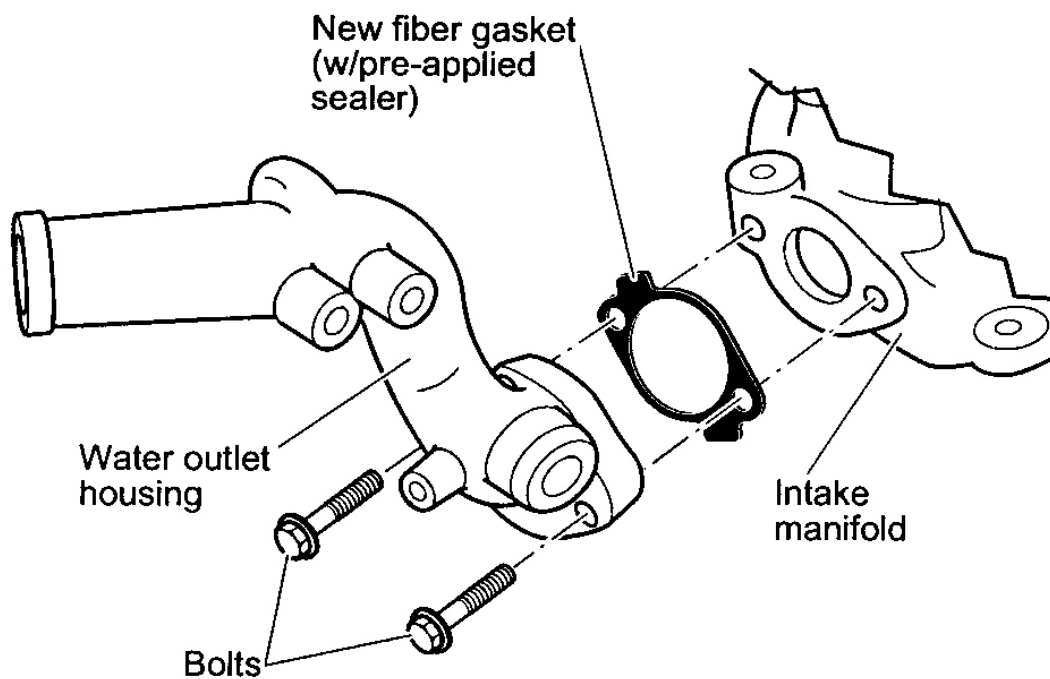
[Fig. 1: Intake Manifold Water Outlet](#)

The cause may be coolant leaking between the water outlet housing and intake manifold sealing surfaces (see **Fig. 1**). Refer to the **SERVICE PROCEDURE** to resolve this incident, should it occur.

Install the new fiber gasket (refer to the [PARTS INFORMATION](#) section) between the water outlet housing and intake manifold as follows:

3. Remove parts necessary to access the water outlet housing.
4. Remove the water outlet housing from the intake manifold.
5. Thoroughly clean the sealing surfaces of the water outlet housing and intake manifold, making sure all old sealer is completely removed.
6. Install the new fiber gasket onto the water outlet housing as follows:
  - A. First, install the two mounting bolts through the holes in the water outlet housing.
  - B. Then, slide the fiber gasket over the bolts until it is flush against the sealing surface of the housing. The bolts will keep the gasket in place while installing the housing.
7. Install the water outlet housing to the intake manifold and tighten the bolts to 16.3-20.3 N.m (1.7-2.1 Kg-m, 12-15 ft-lbs).
8. Re-install all components that were previously removed.
9. Re-fill the radiator:
  - With the coolant that was drained and captured in step 2
