FORD:
2006-2007 Fusion

LINCOLN:
2006 Zephyr

MERCURY:
2006-2007 Milan

TSB 07-14-7 (Continued)

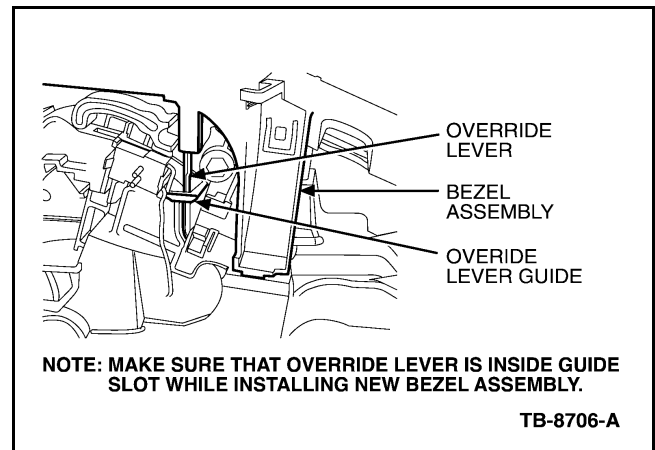
Figure 1 - Article 07-14-7

Shifter Slider Binding:

1. If shifter slider is bunched up or binding, replace bezel assembly following WSM, Section 307-05.

WHEN REPLACING THE BEZEL, CARE NEEDS TO BE TAKEN TO ENSURE THAT THE BRAKE SHIFT INTERLOCK OVERRIDE TAB IS PROPERLY ALIGNED INTO ITS GUIDE. REFER TO FIGURE 1.
