SERVICE BULLETIN

Classification: EC05-006a	Reference: NTB05-037a	Date: June 11, 2009
------------------------------	--------------------------	------------------------

MIL "ON" WITH DTC P1402 (EGR OPEN) CODE STORED

APPLIED VEHICLE(S): 2004-2005 Maxima (A34) and Quest (V42),
2005 Altima (L31) w/VQ35 Engine

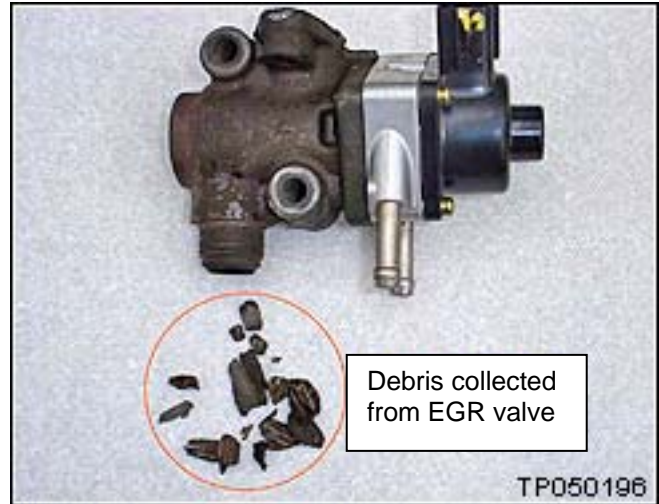
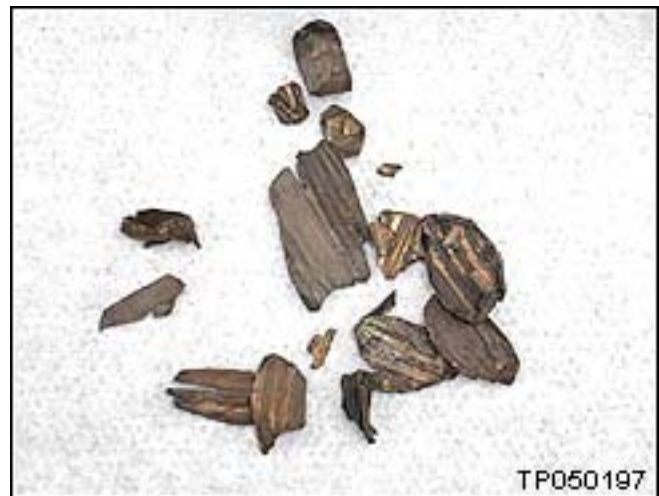
2. Inspect the EGR valve for metallic flake debris. (see Figures 1 and 2)

- Inspect the EGR valve for metallic debris. See the Service Information section of this bulletin for the specific inspection procedure.
- If metallic debris is present, replace the Bank 1 catalyst and EGR valve.

3. If metallic debris is present in the EGR valve, remove Bank 1 catalyst (rear of engine) as per EM section of the respective ESM.

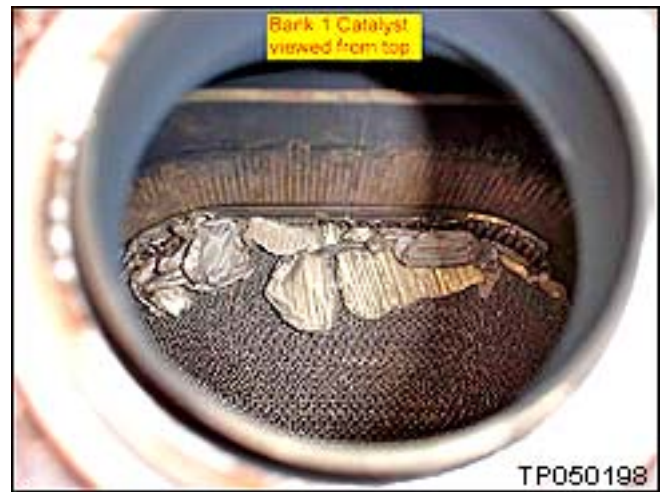
- Bank 1 Catalyst–viewed from the top. (see Figure 3)

5. If the catalyst has loose material as seen in Figure 3 above, blow out the debris from interior of Bank 1 exhaust manifold. Remove the EGR valve and tube, and then blow out any debris from the EGR valve and tube.
6. Replace the Bank 1 catalyst and EGR valve in the reverse order of removal.
7. Clear stored code P1402 from the ECM memory.
-
