SERVICE BULLETIN

Classification: EM07-001c	Reference: NTB07-042c	Date: December 14, 2009
------------------------------	--------------------------	----------------------------

MAXIMA / ALTIMA / QUEST; BUZZING / WHINING NOISE FROM TIMING CHAIN AREA

APPLIED VEHICLES: 2004-2008 Maxima (A34)
2004-2006 Altima (L31) with VQ35 engine ONLY
2004-2009 Quest (V42)

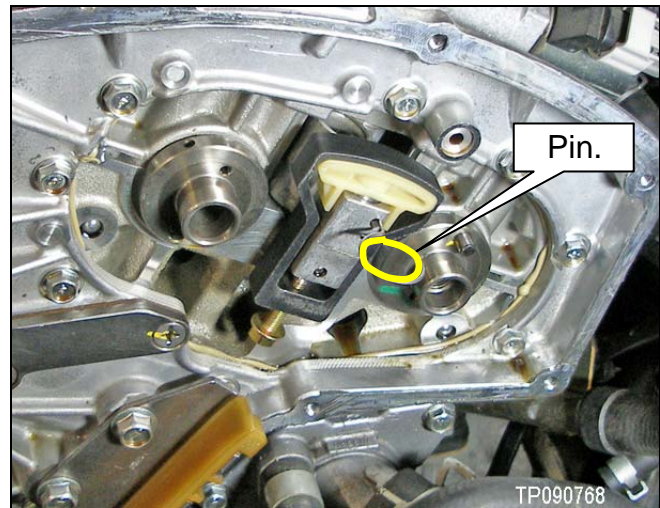
- Use the chain tensioner pins (pin) from Tool Kit J-50246 to hold all three (3) chain tensioner plungers. Figure 1 shows a pin used on B2 tensioner.
