SERVICE BULLETIN

Classification: AT05-008	Reference: NTB05-078	Date: August 24, 2005
-----------------------------	-------------------------	--------------------------

2002 – 2006 ALTIMA AND 2004 MAXIMA; NO UP SHIFT AFTER TRANSMISSION REPLACEMENT

APPLIED VEHICLES: 2002 – 2006 Altima (L31) with 4 speed A/T.
2004 Maxima (A34) with 4 speed A/T.

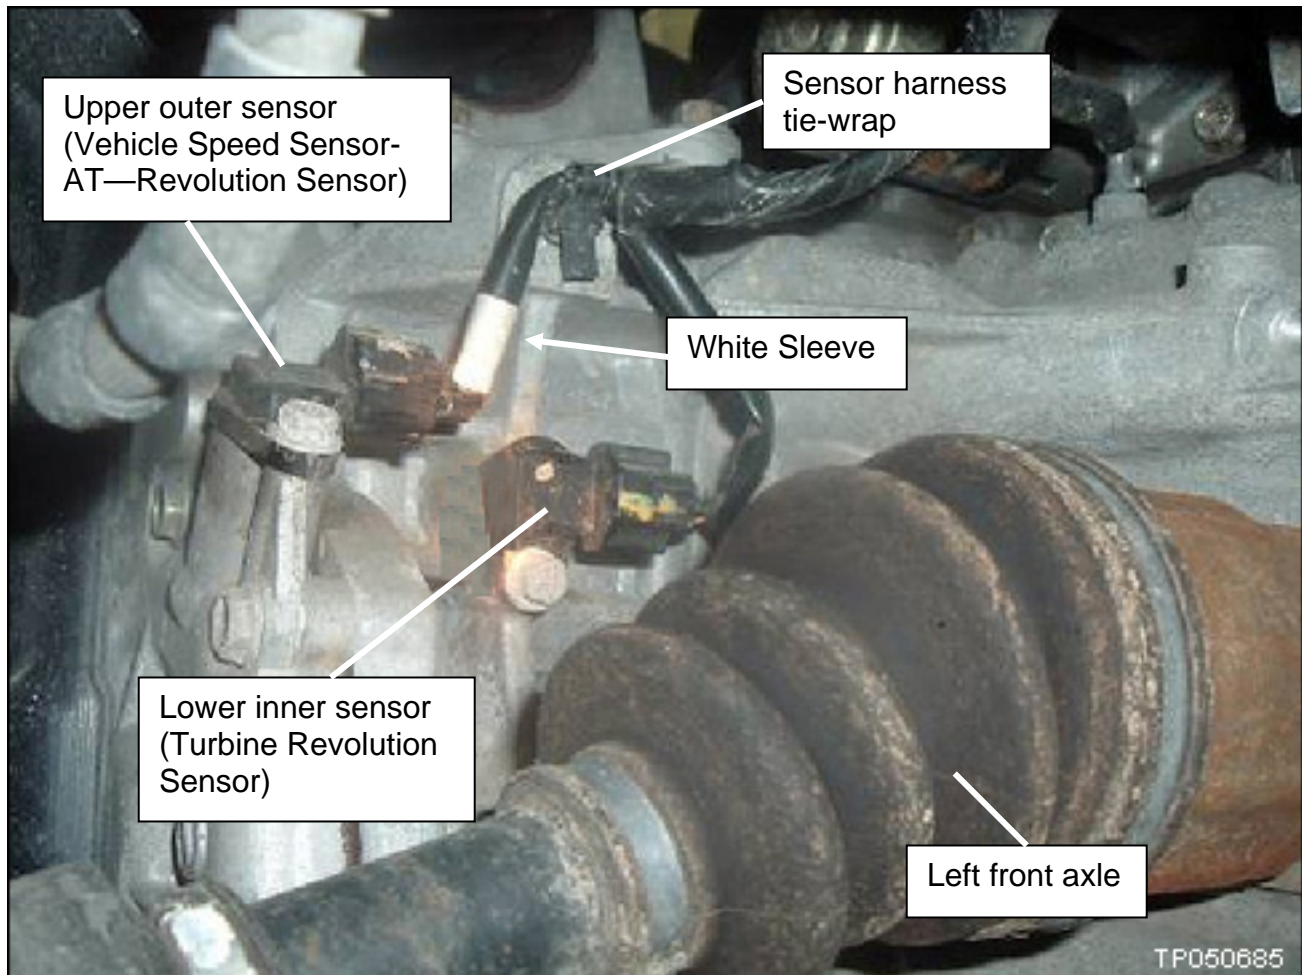
Figure 1

After installing a replacement transmission, it will not up shift from 1st or 2nd gear,
and

DTCs P0720 and P1574 are stored,

1. Check the 2 connectors on the rear left side (driver side) of the transmission for correct installation (see Figure 1). Make sure they're not switched.
 - The connector with the white sleeve on the harness should be plugged into the upper outer sensor (Vehicle Speed Sensor-AT—Revolution Sensor).
 - The connector with no marking on the harness should be plugged into the lower inner sensor (Turbine Revolution Sensor).

- a. If the connectors are installed as described above, this bulletin does not apply. Go back to ASIST for further diagnostic and repair information.
- b. If the connectors are **not** installed as described above; switch them so they are. Reconnect them and secure the sensor harness tie-wrap into the attachment hole as shown in Figure 1.

NOTE: If the harness tie-wrap is properly secured in the attachment hole, the connector with the white sleeve will not reach the lower sensor.
