RECALL CAMPAIGN BULLETIN

NTB04-100a

VOLUNTARY RECALL CAMPAIGN SKYVIEW ROOF GLASS

APPLIED VEHICLE: 2004 Maxima (A34)

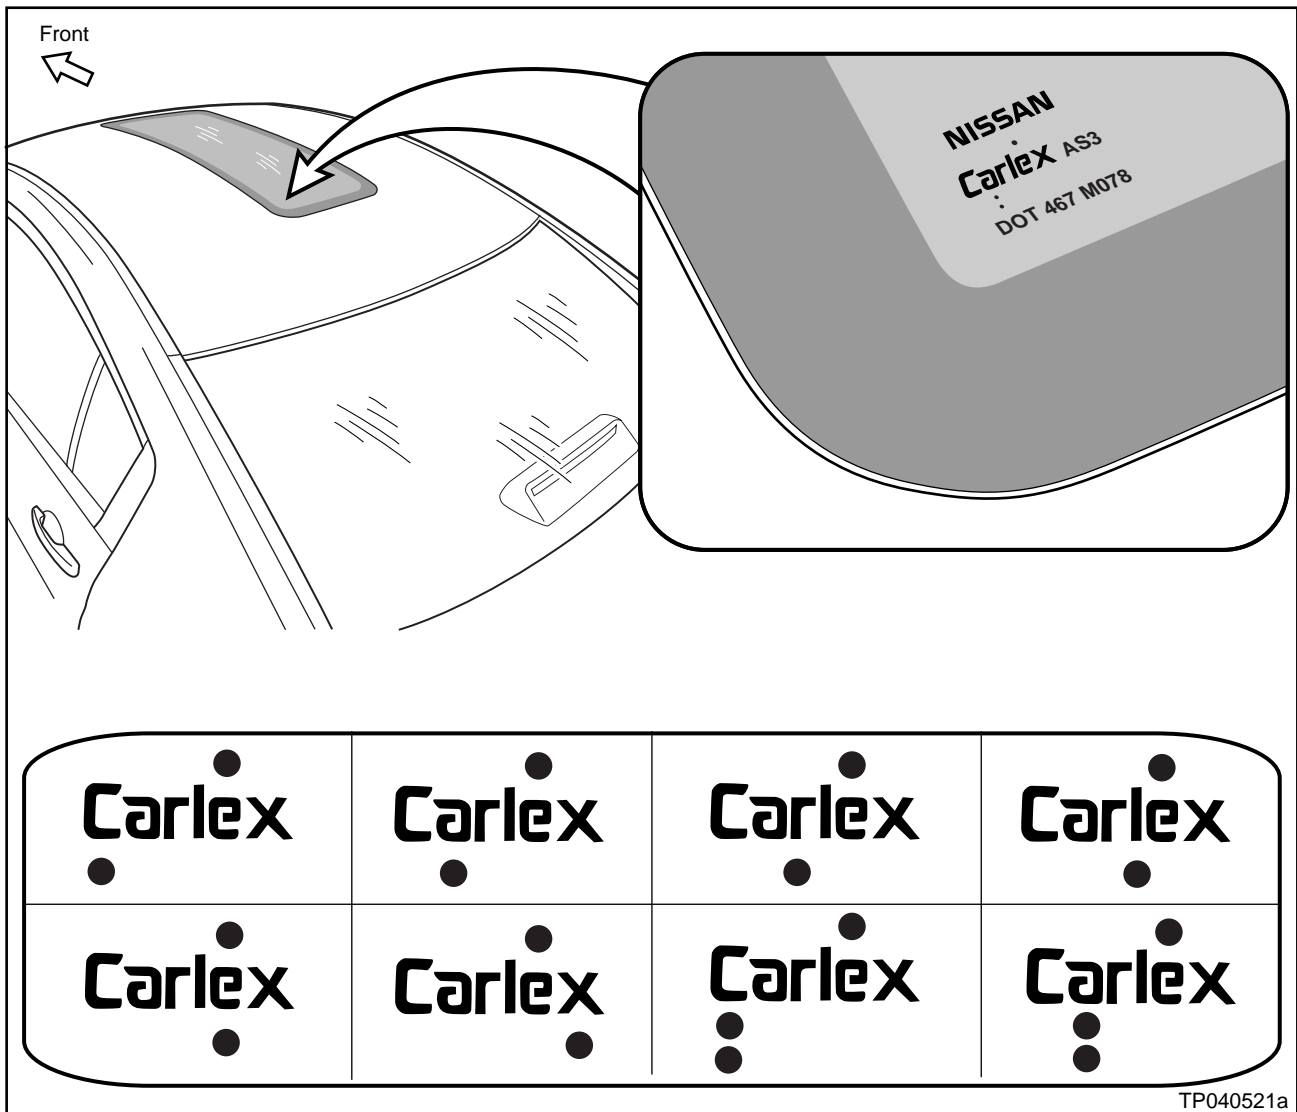
Figure 1

- Replace the Glass if the dots around the "CARLEX" name (located at the driver's side rear corner of the Glass) look like any one of the examples shown in Figure 1. In this case continue with step 2 of this procedure.

- Replace the Glass. Continue with step 2 of this procedure.
