2001-2005 Taurus
2001-2006 Escape

2001-2005 Sable
2005-2006 Mariner

This article supersedes TSB **04-20-8** to update the vehicle model years and Service Procedure.

TSB 06-3-5 (Continued)

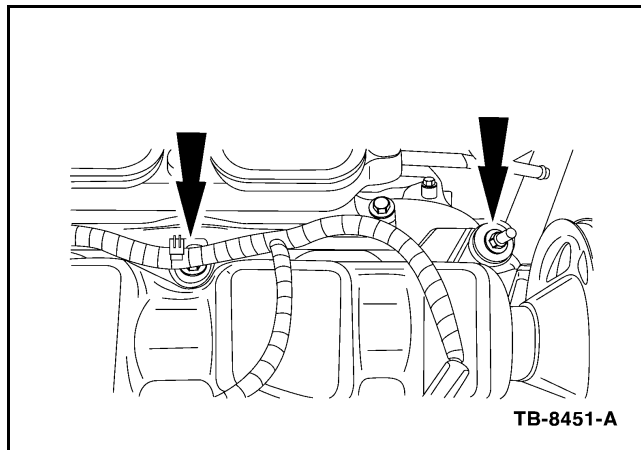
Figure 1 - Article 06-3-5

Some 2001-2005 Taurus/Sable, 2001-2006 Escape and 2005-2006 Mariner vehicles built prior to 1-17-2006 equipped with the 3.0L 4V Duratec engine may exhibit a ticking noise from the left bank cylinder head, with the engine at normal operating temperature only.

To diagnose, with the engine running and warm (normal operation temperature), using a mechanic's stethoscope determine if the ticking noise is coming from the left hand intake camshaft at cylinder number 6, (Figure 1). If the ticking noise can be verified, refer to the following Service Procedure.
