SERVICE BULLETIN

Classification: EC05-007	Reference: NTB05-040	Date: May 25, 2005
-----------------------------	-------------------------	-----------------------

1998 - 2000 FRONTIER & XTERRA WITH KA24 ENGINE; MIL WITH DTC P0400, P0402, ROUGH IDLE, DRIVABILITY INCIDENTS, DIFFICULTY SETTING EGR SRT

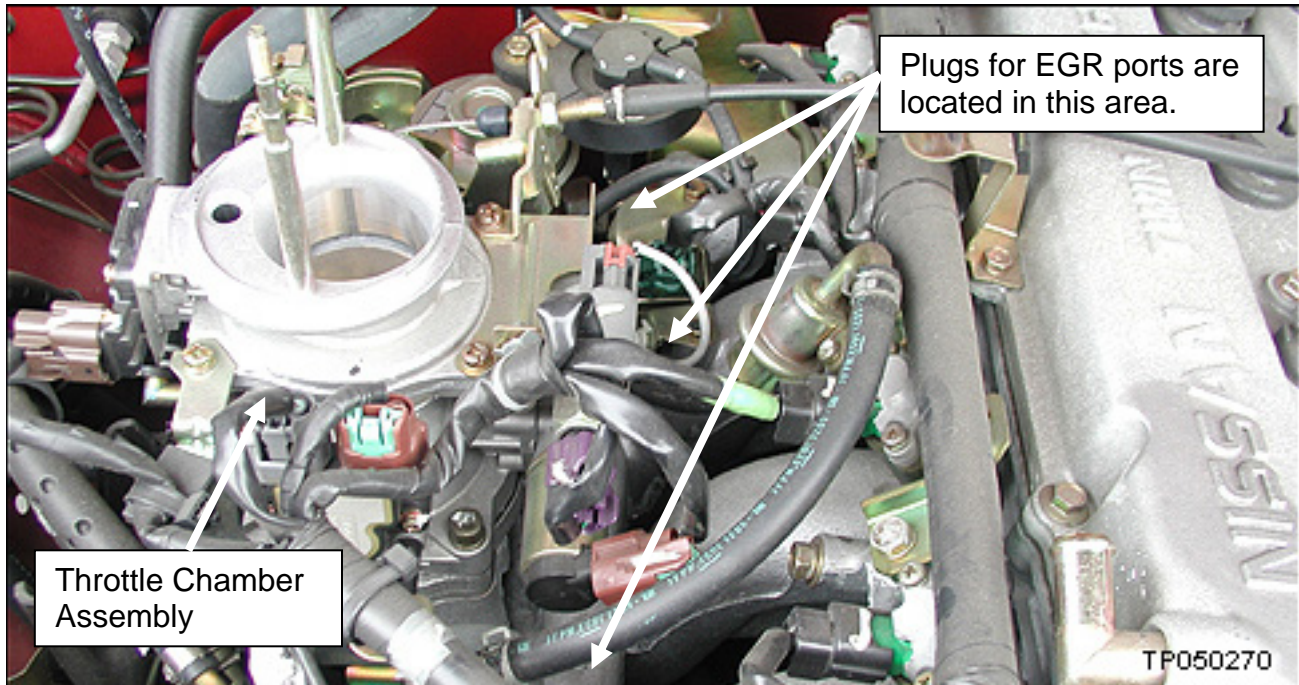
NOTE: Figure 1 gives a general location of the plugs for the EGR ports, but the plugs are not visible in the photo.

- Remove the throttle chamber assembly and place it aside.
 - Refer to the EM section of the appropriate Service Manual (ESM).

NOTE: It is not necessary to completely remove the throttle chamber assembly.

- Only remove harness connectors, cables, and hoses necessary to allow the throttle chamber assembly to be placed aside.
- Throttle chamber coolant hoses do not need to be removed.**
