**WATER LEAK IN HEADLINER/DOME LAMP AREA—
VEHICLES EQUIPPED WITH ROOF OPENING PANEL
AND SAFETY CANOPY AIR BAG SYSTEMS—BUILT
BEFORE 3/27/2007**

TSB 07-20-6

FORD:
2006-2007 Explorer

MERCURY:
2006-2007 Mountaineer

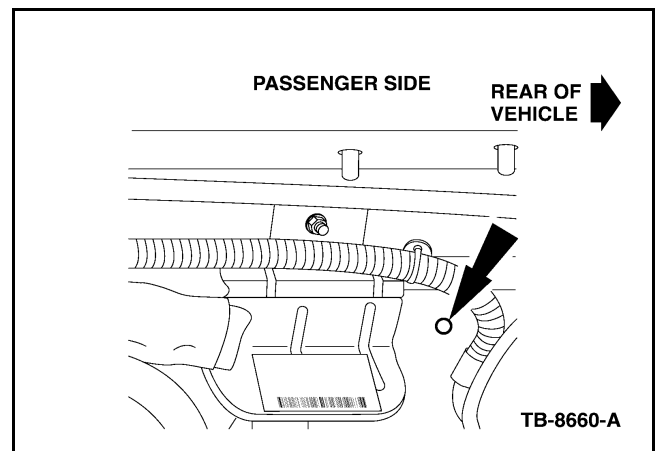
Figure 1 - Article 07-20-6

IF A HOLE HAS BEEN DRILLED IN THE LOWER REAR CORNER OF THE RECTANGLE BRACKET (FIGURE 1) GO TO STEP 5. IF THE VEHICLE WAS BUILT AFTER 8/14/2006 DRILLING A 1/4" HOLE IS NOT REQUIRED.

3. Drill a 1/4" (6.7 mm) hole, 3/4" (20 mm) rearward from the lower rear corner of the rectangle. (Figure 1)

TO PREVENT DAMAGE TO OUTER SKIN SHEET METAL USE A DRILL STOP AND DO NOT ALLOW THE DRILL BIT TO STRIKE OUTER PANEL AS IT PASSES THROUGH THE INNER PANEL.
