VIGIL and Kysor VIP Lightbar Turn Signal Wiring

54-26

**Freightliner
Service Bulletin**

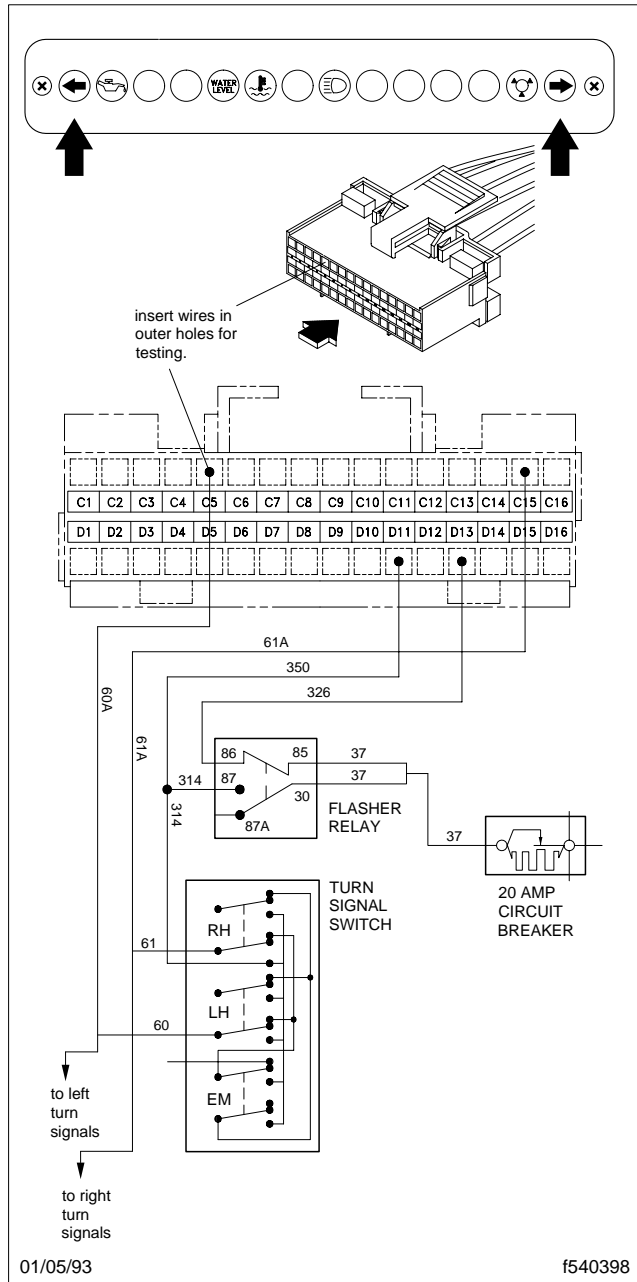
Fig. 1

Previously, if the turn signal lamps would not flash due to a problem with the sensing/timing circuit within the lightbar, it was necessary to replace the lightbar.

The turn signal system functions as follows (see Fig. 1). The turn signal sensing/timing is controlled by the VIGIL or Kysor VIP lightbar. Whenever the turn signal switch is actuated, wire 60 (left turn) or 61 (right turn) is connected to wire 314/350. When the lightbar senses this ground path through wire 350, it starts its turn signal timing circuit by grounding wire 326. When wire 326 is grounded, power is sent through the flasher relay (wire 314) to the turn signal switch and out to the turn signal lamps. This continues until the turn signal switch is released.
