#06-06-04-046: Information on Engine Misfire MIL/SES Light Illuminated or Flashing DTC P0300, P0301, P0302, P0303, P0304, P0305, P0306, P0307, P0308, P0420 or P0430 - (Sep 12, 2006)

Subject: Information on Engine Misfire MIL/SES Light Illuminated or Flashing DTC P0300, P0301, P0302, P0303, P0304, P0305, P0306, P0307, P0308, P0420 or P0430

Models: 1999-2007 Cadillac, Chevrolet, GMC Full-Size Pickup and/or Utility Trucks
with 4.8L, 5.3L, 5.7L, 6.0L or 6.2L VORTEC GEN III, GEN IV, V-8 Engine (VINs V, C, T, Z, B, 3, M, O, J, R, U, N, Y, K, 8 -- RPOs LR4, LY2, LM7, L59, L33, LC9, LH6, LMG, LY5, L31, LQ4, LQ9, L76, LY6, L92)
with Active Fuel Management™ and E85 Flex Fuel

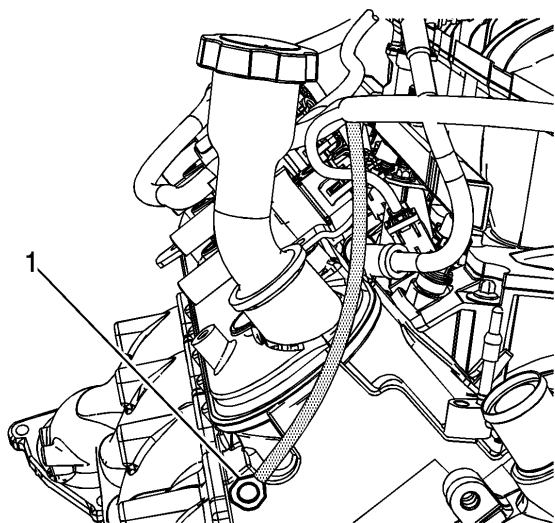
Engine Wiring Harness Ground Terminal Location (2007 Full-Size Pickup and/or Utility Trucks)

If you encounter vehicles that exhibit the above conditions, refer to SI for the appropriate DTC (s) set. If no trouble is found, the cause may be due to an ECM ground terminal that has corroded with rust over time. Inspect the main engine wiring harness ground terminal (G103) for this condition.

The wire terminal (G103) attaches either to the front or to the rear of the right side cylinder head, depending on the model year of the Full Size Pickup and/or Utility Trucks. If the ECM ground terminal has been found to be corroded, then follow the service procedure outlined in this bulletin to correct the corrosion issue.

1. Remove either the nut or bolt securing the main engine wiring harness ground terminal (G103) to the right cylinder head. Refer to the above illustration to determine where the ground is located on the vehicle (1).
2. Remove all rust from the ground terminal, the cylinder head and the retaining nut or bolt.
3. Position the main engine wiring harness ground terminal and install the nut or bolt.

Tighten the retaining nut or bolt to 16 N·m (12 lb ft).

4. Apply some type of electrical moisture sealant to protect the harness terminal from further corrosion.
