# **#06-07-30-004C: Various Concerns with Shifter and/or Ignition Key (Replace Shifter Assembly/Shifter Components or Ignition Lock Cylinder) - (Jun 27, 2006)**

**Models:** 2005-2007 Chevrolet Cobalt  
2005-2006 Pontiac Pursuit (Canada Only)  
2007 Pontiac G5  
with Automatic Transmission 4T45-E (RPO MN5)

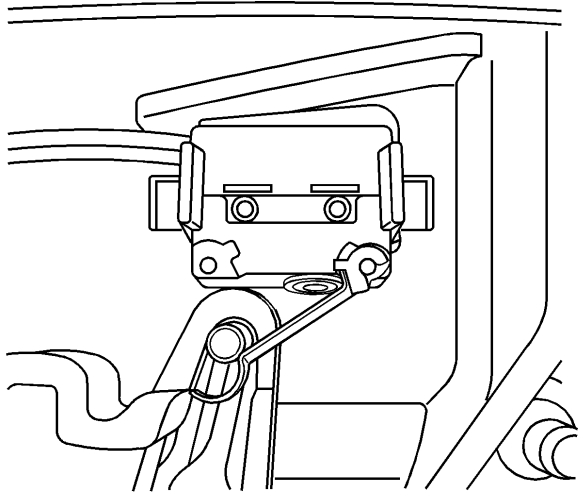
The pin that activates the micro-switch may have moved out of position (refer to illustration above). This causes the micro-switch to fail to engage when the vehicle is placed in Park. If this condition is present, the customer will not be able to remove the key from the ignition.

Verify that the micro switch is out of position. Replace the shifter assembly. Refer to Transmission Control Replacement in SI.

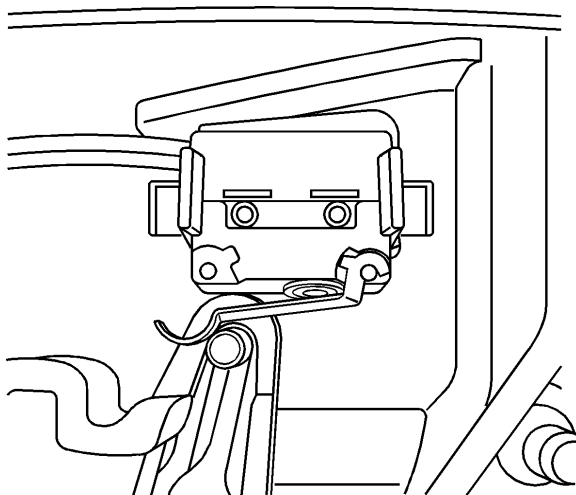
The illustration above shows the switch in a correct position.
