#05-08-67-014K: General Guide to Panoramic Sunroof Noise Issues (WPC P/N 401) - (Apr 7, 2008)

Models: 2005-2007 Pontiac G6
2007 Saturn Aura

This bulletin is being revised to update the Parts information. Please discard Corporate Bulletin Number 05-08-67-014J (Section 08 - Body and Accessories).

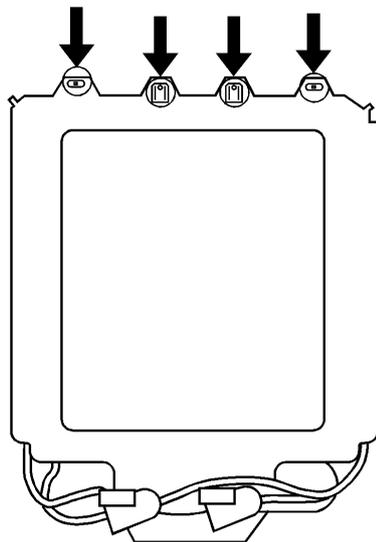
Figure 1

Some customers may comment on creak/snap/pop type noise from the sunroof module that occurs while driving over bumps.

This condition may be caused by the module mounting bolts/fasteners (roof interaction with the fasteners).

1. Install 28 Mylar washers to the mounting bolts/fasteners. Drop the headliner enough to access these attachments, being careful not to bend or damage the headliner while performing the following procedure. Loosen all front 4 module mounting bolts (refer to figure 1). Verify that the screws are not engaged into the roof.

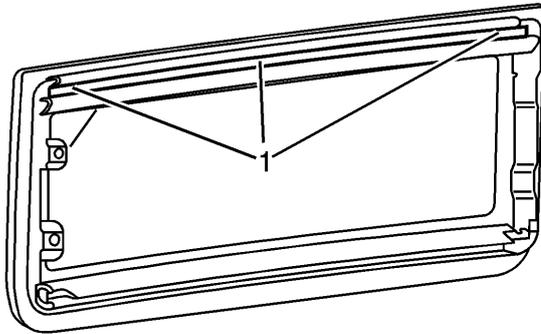
Some customers may comment on wind noise coming from the glass panel areas of the sunroof. This condition could also be reported as a HVAC blower motor whistle type noise that changes with HVAC blower fan speed.

This condition may be caused by one of more glass panels out of adjustment and not sealing properly.

1. Install cross car foam to the first three glass panels of the module. The cross car foam is installed on the extruded glass reinforcement in the channel area (back of the glass panel on the inside). This is best done when the sunroof is open all the way. To install cross car foam, clean the extruded glass reinforcement channel with alcohol. Install the cross car foam in the channel area, centered from one end to the other on the first glass panel (refer to figure 8). Figure 8 shows the underside of the 1st panel with the foam strip added to the extruded glass reinforcement. This foam acts as a sound deadener

Important: The foam should be seated evenly in the channel and across the panel to ensure proper glass panel sealing.

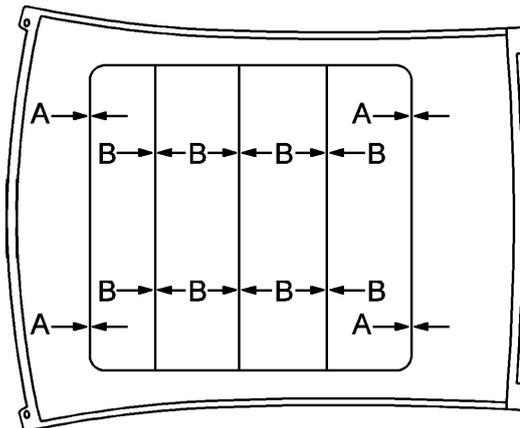
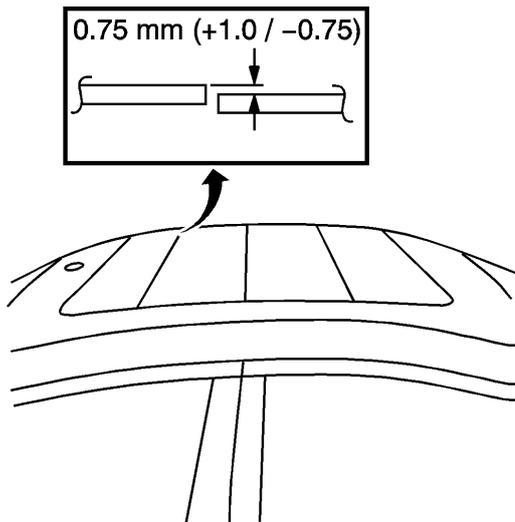
A = Gap between glass edge to metal roof edge. Panoramic Roof (Gap) 4.0 +/- 1.5 mm (front). Panoramic Roof (Gap) 4.0 +/- 1.5 mm (Rear)

B = Gap between glass panels. 4.0 mm +/- 1.5 mm Glass gap between 1st & 2nd, 2nd & 3rd and 3rd & 4th panels.

Important: It is always desirable to have glass panels display a slight shingle effect (refer to figure 12).

5. Cycle the roof to the full open and back to its closed position. Verify the glass panels are within the measurement specifications (refer to figures 11 & 12).

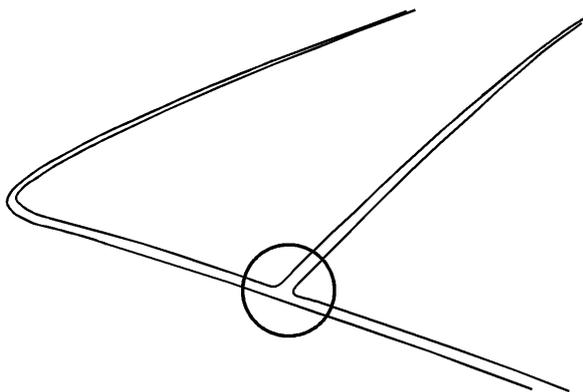
Figure 13

Important: Keep in mind that some air leakage is normal at the T-joint areas and are there by design (refer to figure 13).

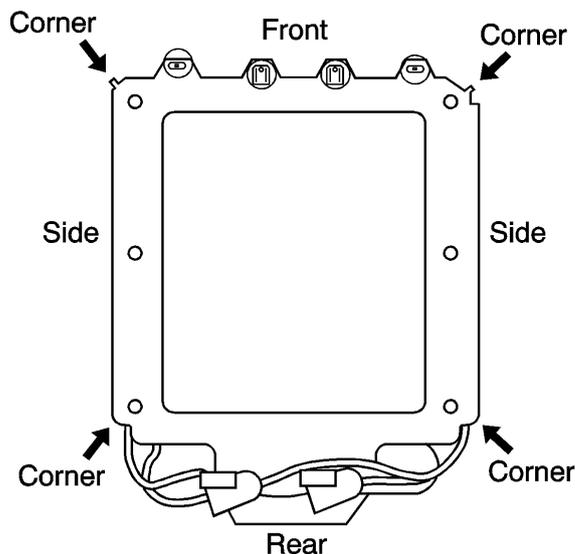
Figure 14

Some customers may comment on wind noise/wind rush type noise coming from outside of the vehicle in the sunroof module seal to roof area.

This condition may be caused by a lack of seal compression from the sunroof module to metal roof.

- If the noise is coming from the front center of the sunroof module (refer to figure 14), loosen all front 4 module mounting bolts (refer to figure 1). Verify that the compensators are not engaged into the roof. Spin all front four compensator barrels all the way down (refer to figure 3).

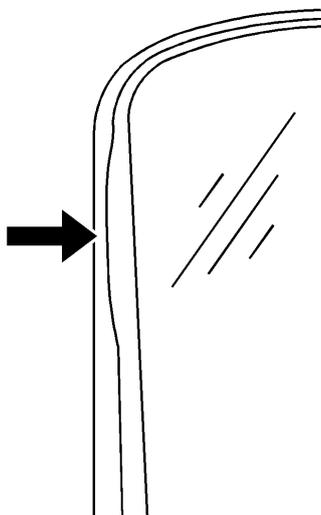
A rolled seal and/or a puckered seal at one of the corners at the module.

Incorrect position rolled seal.

Repair rolled perimeter seal by spooning into position with "Trim Stick" or credit card type tool.

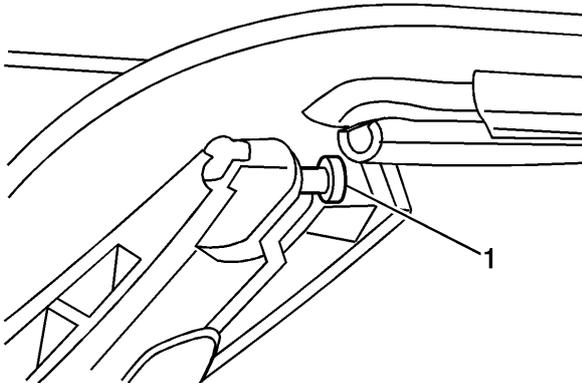
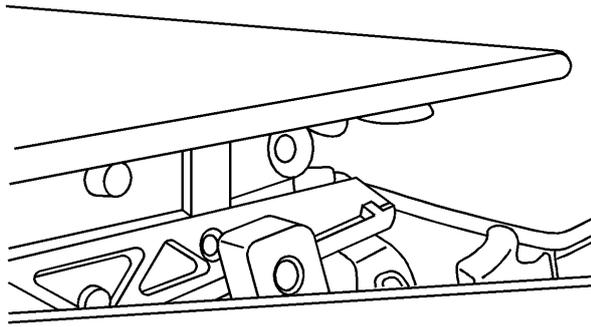
Some customers may comment on glass panel rattling or loose.

Glass panel retention pins loose or missing.

DO NOT order an entire sunroof module to get the retention pins. *The pins are available through the Warranty Parts Center. Request P/N 401 (2 pins per order).*

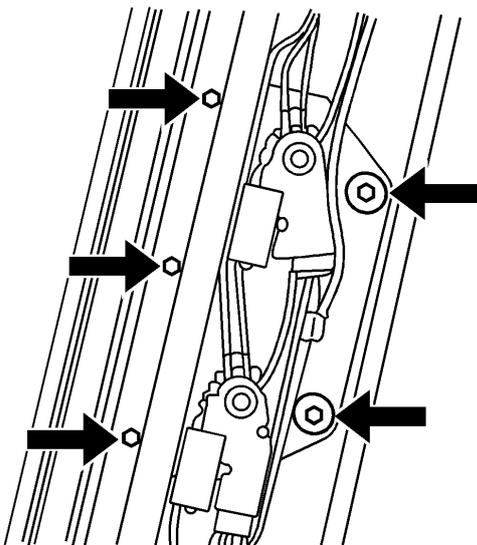
Figure 20

Customers may comment on a plastic/metal rattle type noise that occurs while driving over bumps. This noise usually comes from the rear of the sunroof module.

This condition may be caused by loose mounting bolts/fasteners.

1. Partially lower the headliner enough to access these attachments, being careful not to bend or damage the headliner while performing the following procedure. Loosen all (5) rear center mounting bolts and then re-tighten all (5) center mounting bolts at the rear of

the module to 10 N·m (89 lb in). Note that the forward 3 mounting bolts are accessed by the holes in the sunshade when the sunshade is fully closed (refer to figure 20).

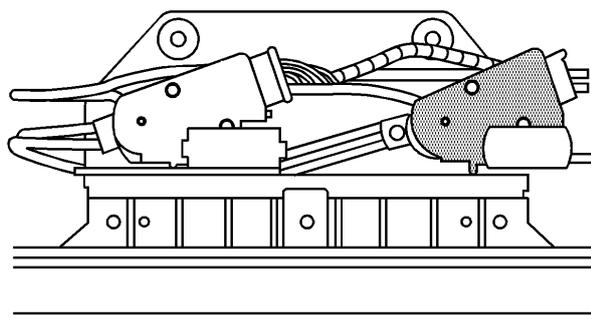
Figure 23

After servicing the sunroof module, the sunshade does not cycle.

This condition may be caused by an incorrect drive motor on the sunshade.

Since both these motor have different internal software, verify that the sunshade motor (passenger side motor) has a black case. (The white case motor is the glass drive motor [driver side motor]) (refer to figure 23).

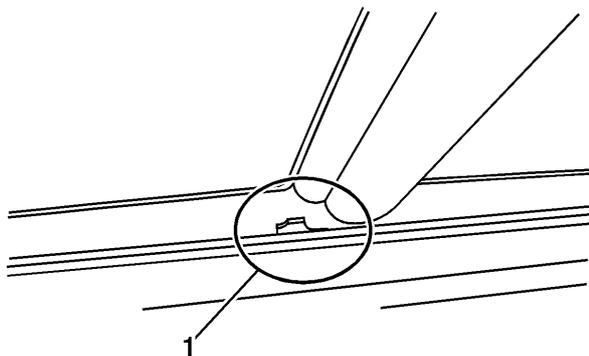
Figure 24

Customer may comment on light coming through the T-joints areas.

It is important to note that this is caused by a clear area in the glass black out for the GM Glass part number. This is a normal condition and is not actual opening in the glass.

If the customer does not accept this explanation, use a black permanent marker to "black-out" the area (refer to figure 24).

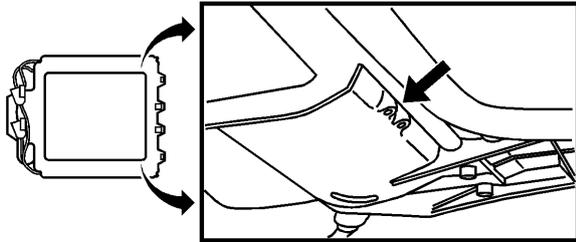
Figure 25

Some customers may comment on an itch type noise occurring over bumps. The noise comes from the front area of headliner at the corners where headliner meets the sunroof module, over the driver's and/or front passenger's head area.

The headliner may rub on a pair of plastic screw boss holes (empty/no screws in these bosses) that are part of the sunroof module on each side of the module towards the front (refer to figure 25).

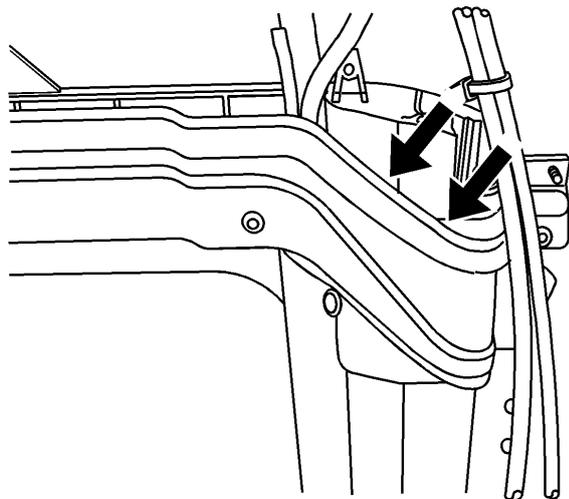
Some customers may comment of a squeak or itch noise over bumps at the rear of the sunroof.

The metal frame of the sunroof module may be contacting the plastic portion of the sunroof module.

Loosen the metal frame and insert a piece of 3M™ squeak reduction tape, P/N 06356, between the plastic and metal frame.
