#00-07-30-007A: Whine Noise in Park or Neutral, Service Engine Soon or Service Vehicle Soon Lamp Illuminates (Replace Drive Sprocket Support Bearing) - (Jan 30, 2002)

Models: 1999-2000 Buick LeSabre, Park Avenue/Ultra, Regal, Riviera
 1999-2000 Chevrolet Lumina, Monte Carlo, Venture
 2000 Chevrolet Impala
 1999 Oldsmobile Eighty Eight
 1999-2000 Oldsmobile Intrigue, Silhouette
 1999-2000 Pontiac Bonneville, Grand Prix, Montana
 with 3.4L, 3.5L or 3.8L Engine (VINs E, H, K, 1 -- RPOs LA1, LX5, L36, L67)
 and Hydra-Matic 4T65-E Transaxle/Transmission (RPOs MN3, MN7, M15)

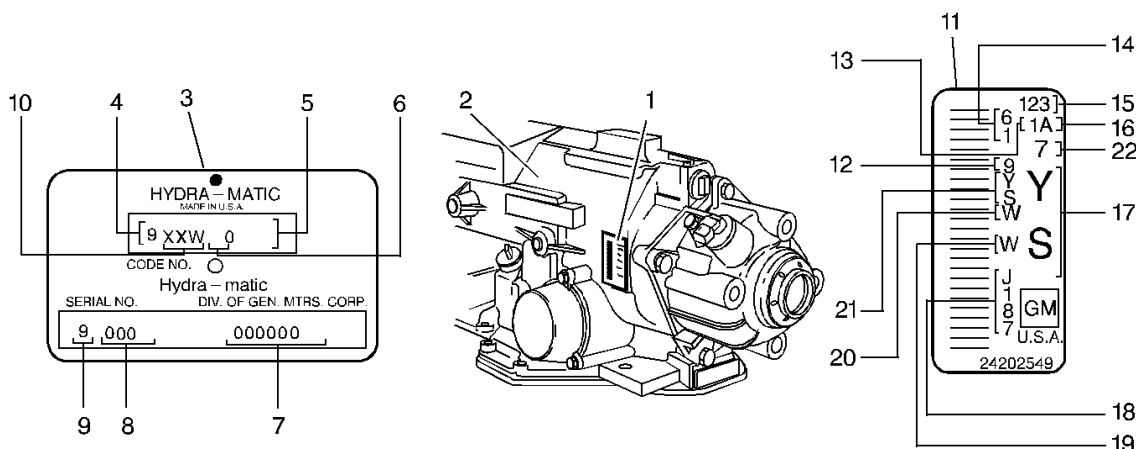
- (1) Transmission ID Location
- (2) SRTA Tag Location
- (3) Hydra-Matic 4T65-E SRTA Tag
- (4) Model Year (9 = 1999)

- (5) Control Number
- (6) Transmission
- (7) Serial Number
- (8) Julian Date
- (9) Calendar Year (9 = 1999)
- (10) Model
- (11) Hydra-Matic 4T65-E ID Tag
- (12) Model Year (9 = 1999)
- (13) Line Built (1 = Line 1; 2 = Line 2; 3 = Line 3; 4 = Line 4)
- (14) Transmission
- (15) Julian Date
- (16) Shift Built (A = First Shift; B = Second Shift; C = Third Shift)
- (17) Model
- (18) Serial Number in Base Code 31
- (19) W = Warren Plant
- (20) Hydra-Matic 4T65-E
- (21) Model

Some owners of the above models equipped with a Hydra-Matic 4T65-E transaxle with a Julian Date prior to 0045 may comment on a whine noise in PARK and/or NEUTRAL or a Service Engine Soon or Service Vehicle Soon lamp that is illuminated. Upon investigation, a DTC P0741 or P0742 may be found.
