#06-07-30-007A: Malfunction Indicator Lamp (MIL) On, Diagnostic Trouble Code (DTC) P0894, Harsh 1-2 Shift with 4L60-E, 4L65-E, 4L70-E Auto Transmission (Test/Replace TCC Enable Solenoid/Harness, Auto Trans Wiring) - (Feb 20, 2007)

Models: 2006 Cadillac Escalade Models
2006 Chevrolet Light Duty Trucks
2006 Chevrolet Express Vans
2006 GMC Light Duty Trucks
2006 GMC Savana Vans
2006 Pontiac GTO
2006 HUMMER H2, H3
2006 Saab 9-7X
with 4L60-E / 4L65-E / 4L70-E (RPOs M30, M32, M70) Automatic Transmission

This bulletin is being revised to add part number for vehicles with Input Speed Sensor (ISS). Please discard Corporate Bulletin Number 06-07-30-007 (Section 07 -- Transmission/Transaxle).

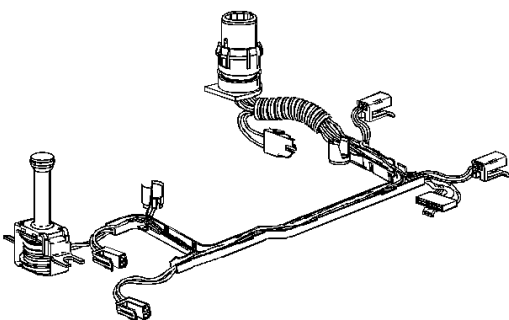
This condition may be caused by a leaking TCC enable solenoid. The TCC enable solenoid is part of the automatic transmission wiring harness.

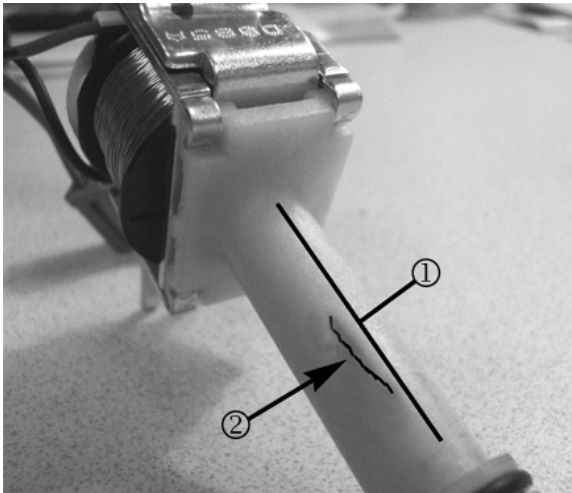
- Typically if the TCC enable solenoid is found to have a crack / fracture (2), it will be located parallel to the mold seam (1) as shown above.
 - Engineering investigation shows that TCC enable solenoids that are brown in color may exhibit the cracking / fracture condition.
 - Engineering investigation shows that TCC enable solenoids that are off-white in color do not exhibit the cracking / fracture condition.
3. Air check the TCC enable solenoid using J 44246 solenoid testing kit.
