2003 Land Rover Freelander (LN) V6-2.5L

Campaign - Fuel Pump Replacement

No: Q057

SERVICE ACTION: Fuel Pump Module Operation

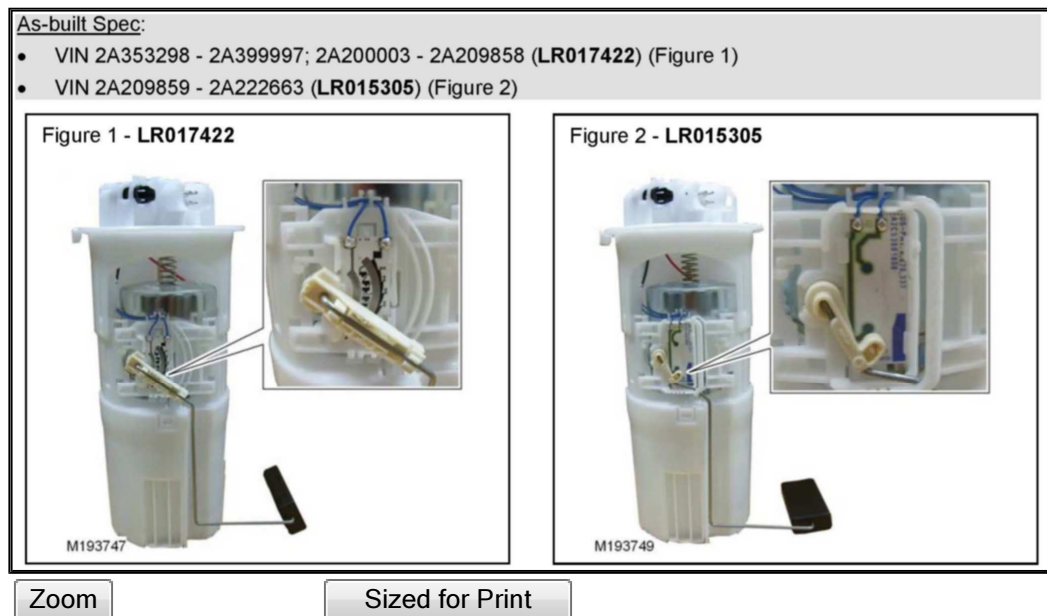
Due to the possibility of past repairs to the fuel pump module / sender unit being performed incorrectly, it is necessary to physically compare the existing fuel pump module to the recommended replacement. Ensure the new fuel pump module matches the existing prior to installation. Failure to do so will lead to incorrect fuel gauge operation.

2. Compare existing fuel pump module sender unit to new fuel pump module sender unit, ensuring correct fuel pump module is installed as shown above.
