**1992 Mazda MX-5 Miata L4-1597cc 1.6L DOHC**[Vehicle Level](#) → [Windows and Glass](#) → [Window Regulator](#) → [Technical Service Bulletins](#) → [All Technical Service Bulletins](#) → [Window Regulator - Hard To Operate](#) ←**Window Regulator - Hard To Operate**[Notes](#)

Bulletin No.: 038/93

DIFFICULT OPERATION OF THE WINDOW REGULATOR

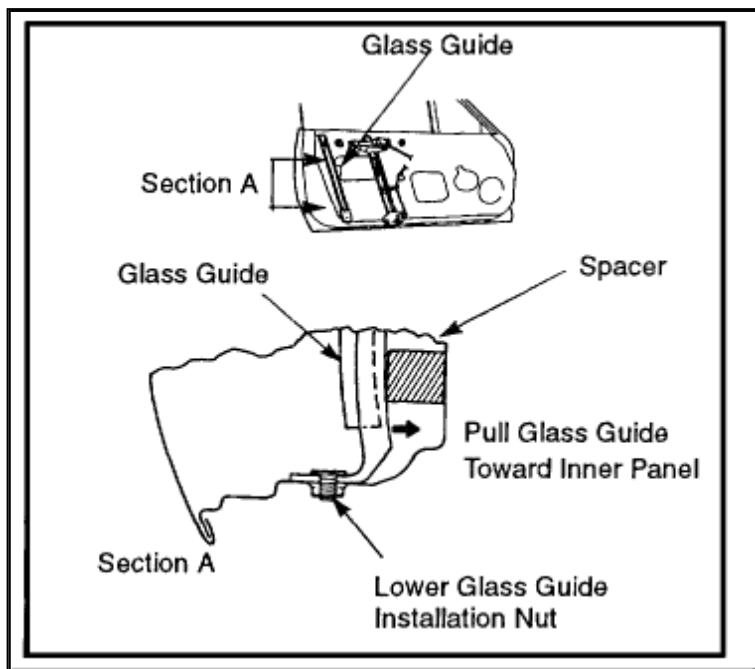
Vehicles with hard to operate window regulators may have twisted glass guides. The glass guide may have been twisted during assembly which causes the window to bind during operation. To prevent this condition, a spacer has been placed in the door body which prevents the glass guide from twisting.

2. Pull the glass guide toward the inner door panel and slightly tighten the lower glass guide installation nut.

**NOTE :** There should be no twist in the glass guide after tightening the lower installation nut.

3. Insert a spacer (approx. 33 - 35 mm wide) between the door panel and the glass guide as shown in the illustration.
4. Tighten the lower glass guide installation nut pulling the nut toward the inner door panel.
5. Remove the spacer, test window and if necessary, adjust the glass guide.
