1994 Chevy Truck C 1500 Truck 2WD V6-262 4.3L VIN Z

Ignition - Timing Connector Location Change

Group Ref.: Engine
Bulletin No.: 366002
Date: January, 1994

SUBJECT:
TIMING CONNECTOR LOCATION CHANGE

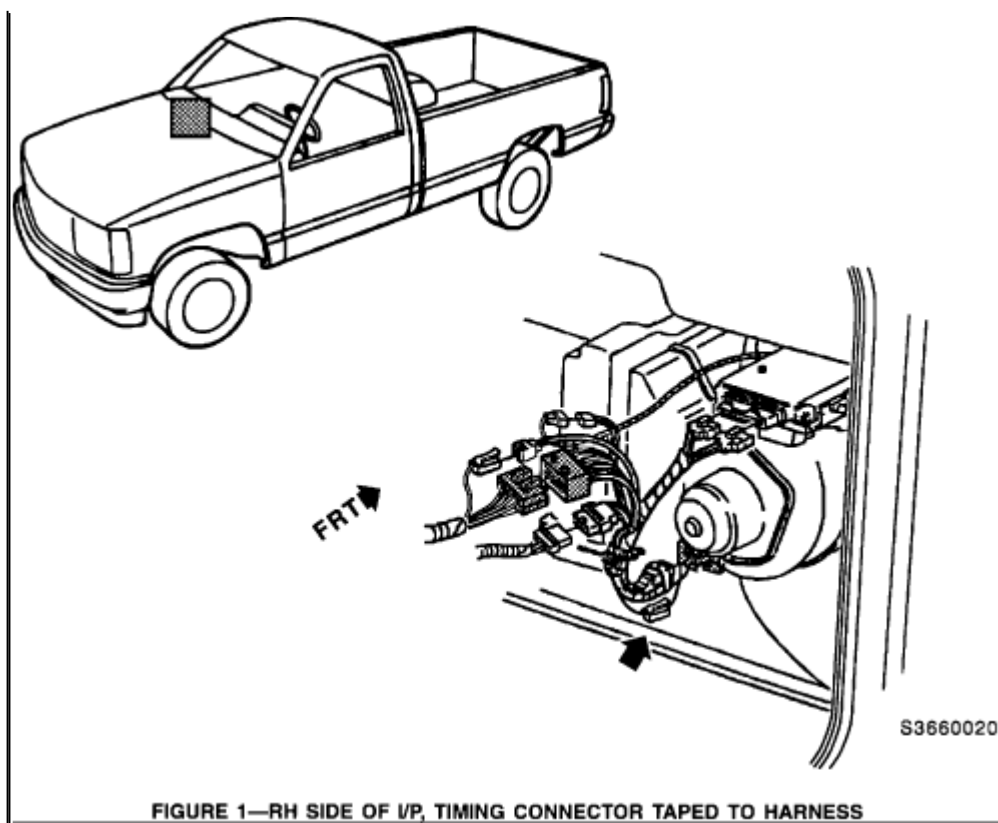
The timing connector, which can be disconnected to return engine timing to base for adjustment purposes, has been moved from the engine compartment to inside the cab. This new location is not currently reflected in the Service or Owner's Manual.

The new location is under the dash directly below the glove compartment. The tan/black wire is routed for a short distance outside of a large wiring harness. This large harness is routed between the heater blower motor and evaporator case. The timing connector is taped to the wire bundle (Figure 1).
