DIAGNOSTIC TROUBLE CODE (DTC) C1145 AND/OR C1155 STORED IN ANTI-LOCK BRAKE SYSTEM (ABS) MODULE

TSB 04-22-13

FORD:
2003-2005 Thunderbird

LINCOLN:
2003-2005 LS

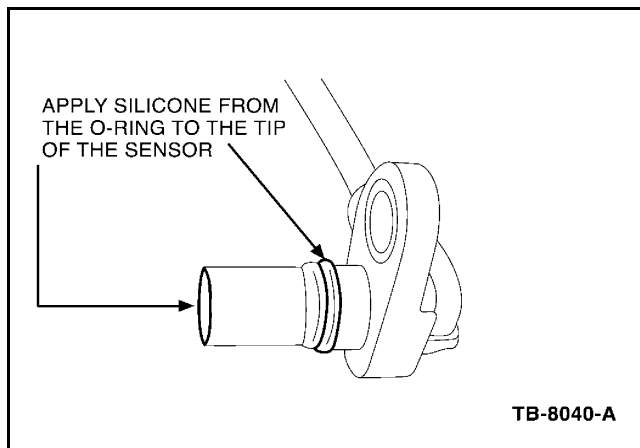
Figure 1 - Article 04-22-13

Some 2003-2005 Lincoln LS and Thunderbird vehicles, equipped with a bolt-on wheel speed sensor, may exhibit the ABS and traction control or advance trac warning lamp illuminated, with DTC C1145 and/or C1155 stored in the ABS module.

1. Per the DTC, replace the appropriate front wheel speed sensor. Refer to Workshop Manual Section 206-09. Apply a thin film of XG-3-A (Motorcraft Silicone Brake Caliper Grease and Dielectric Compound) to the O-ring, and the portion of the sensor which is located in the bearing cap. This includes coating the sides and the end of the sensor cylinder (Figure 1).
