# Service Hint

**Product:** Plasma TV

**Number:** SH-B34-08-03

**Subject:** How to diagnose power LED blinks 7 times symptom.

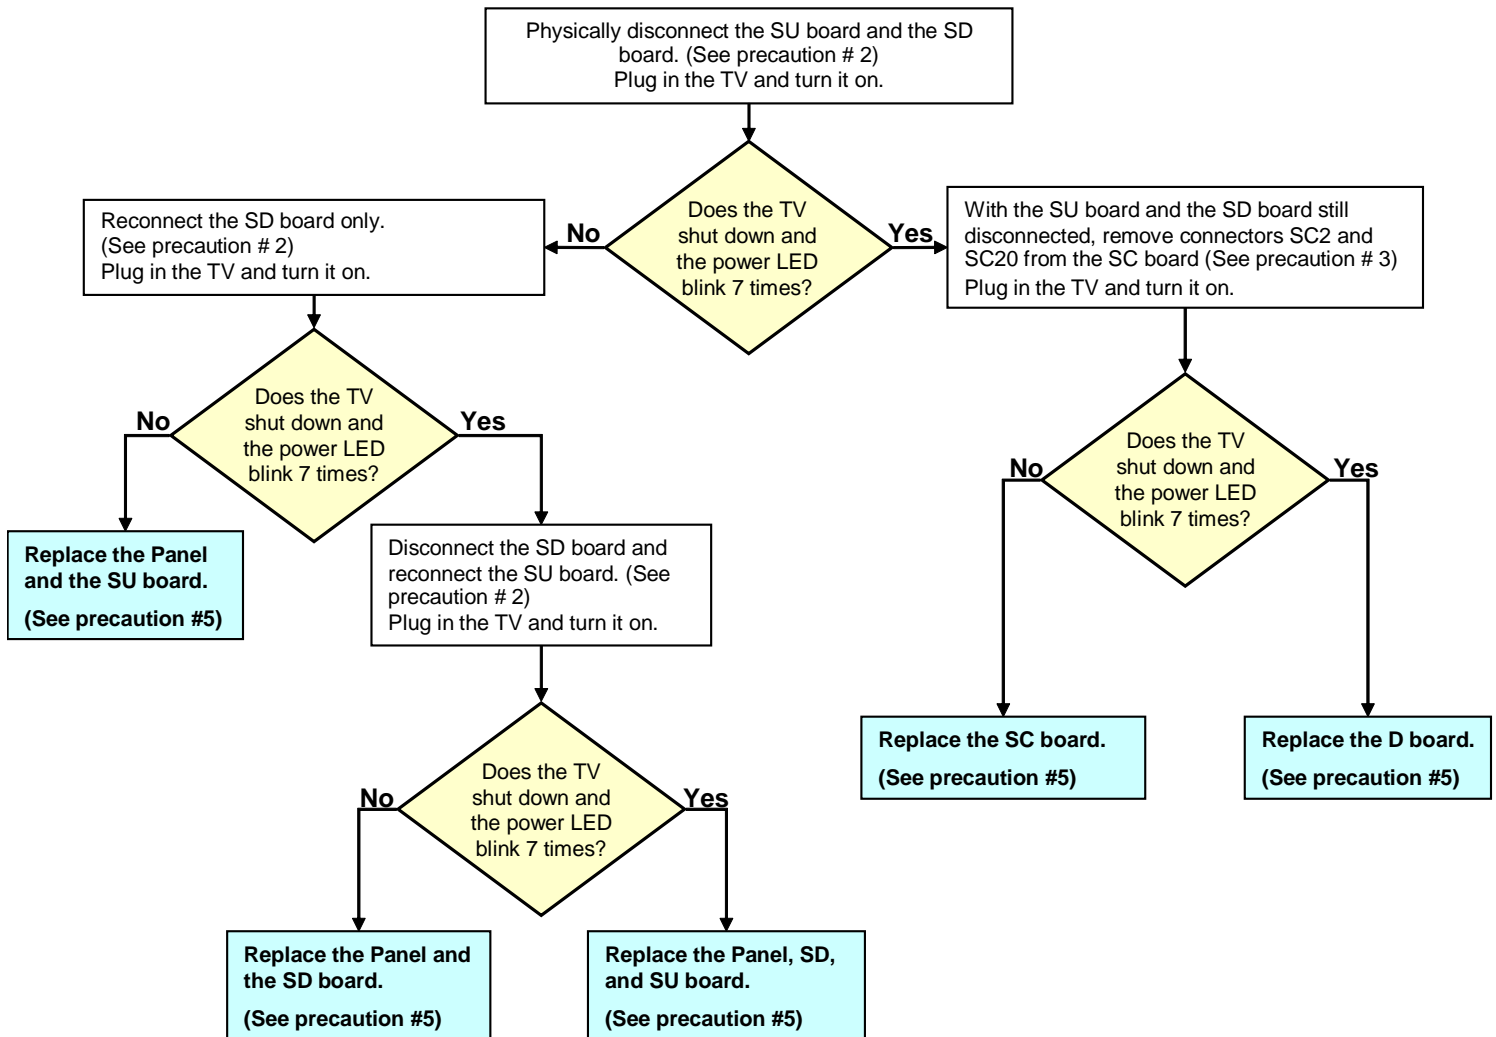
# Troubleshooting flowchart for 7 blinks symptom

1. Conduction between the sustain and scan electrodes causes the output ICs to fail on either the SD or SU board, depending on the location of the damaged pixels. -OR-

2. FET transistors on the SC board fail, preventing the delivery of scan pulses to the panel.

1. Replace the SC board and update the D-board firmware. -OR-

2. Replace the panel and failed drive board (SD or SU) and update the D-board firmware.

1. Disconnect AC Power prior to making or removing any connections!!
2. It's not necessary to remove the panel's flex-cables from connectors SU1~SU4 on the SU board or SD1~SD4 on the SD board when isolating these 2 drive boards.
3. It is necessary to discharge P2/SC2 or P11/SS11 before re-connecting them in order to prevent arcing that may be stored by VSUS voltage.
4. Make sure all the connectors on the SU, SD, SC, and the P boards are seated properly.
5. Upon completion of the repair, perform "D Board Firmware Upgrade" according to the instructions in Service Hints SH-B34-08-01 for model TH-42PZ700U and SH-B34-08-02 for models TH-42PZ77U and TH-42PZ700UA. Firmware can be found here:  
<http://www.pasctraining.panasonic.com/firmware>
