Service Hint

Product: Plasma TV

Number: SH-B34-08-03

Subject: How to diagnose power LED blinks 7 times symptom.

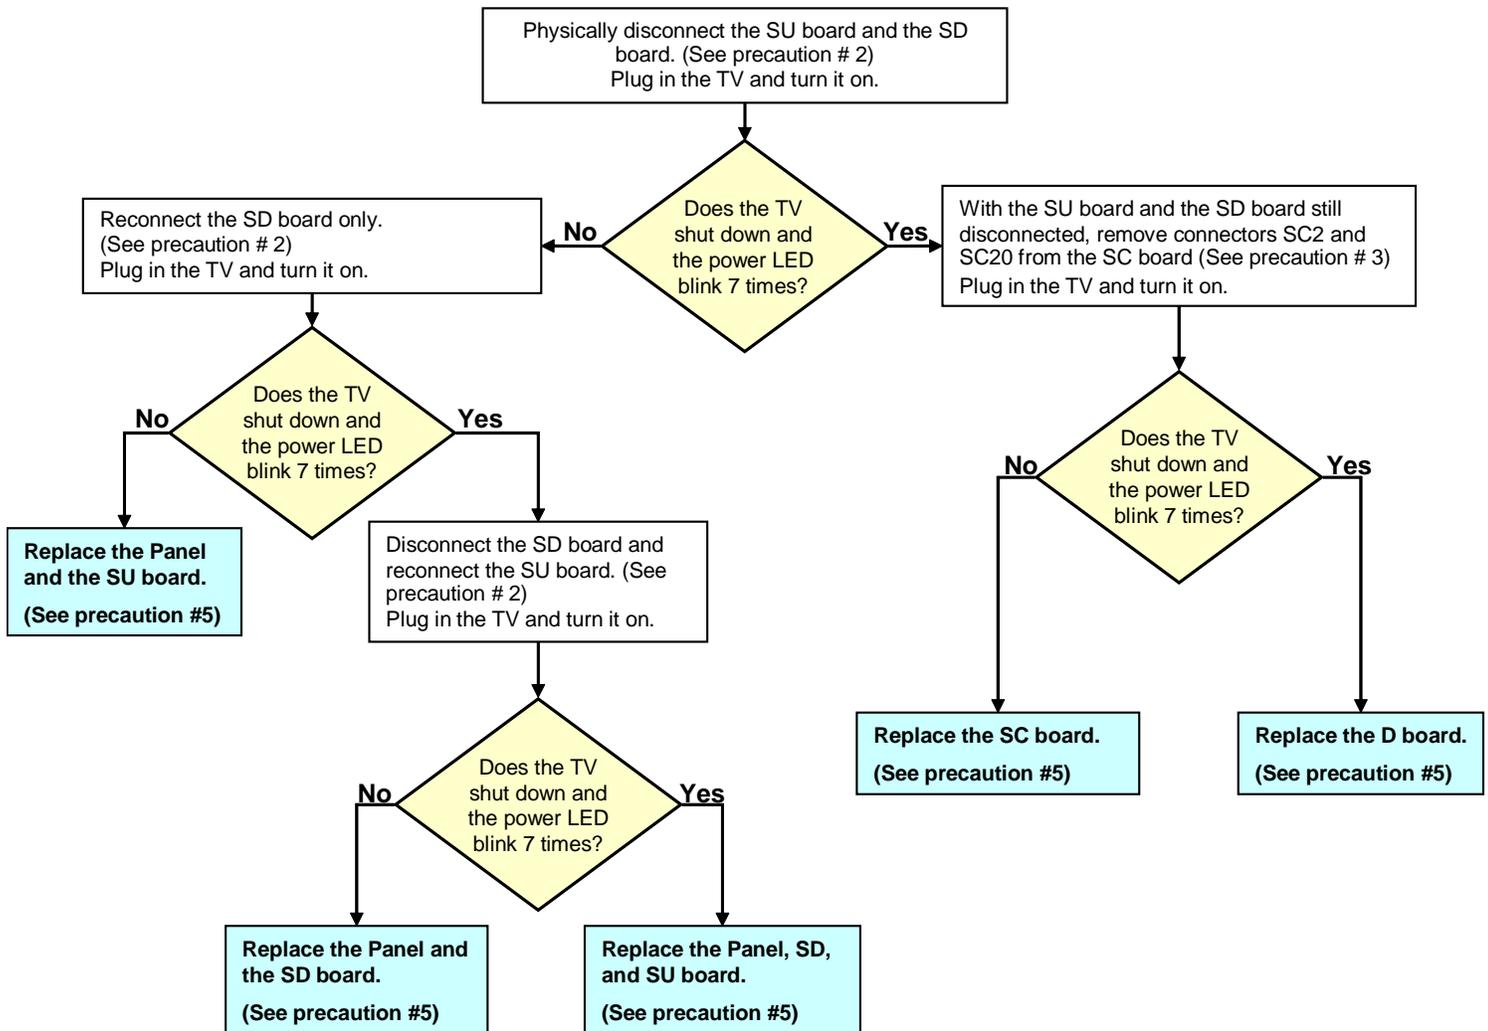
Troubleshooting flowchart for 7 blinks symptom

1. Conduction between the sustain and scan electrodes causes the output ICs to fail on either the SD or SU board, depending on the location of the damaged pixels. -OR-

2. FET transistors on the SC board fail, preventing the delivery of scan pulses to the panel.

1. Replace the SC board and update the D-board firmware. -OR-

2. Replace the panel and failed drive board (SD or SU) and update the D-board firmware.
