#09-06-04-025: Malfunction Indicator Lamp (MIL) Illuminated, DTCs P0300-P0306, Engine Runs Rough (Inspect for Water Intrusion in Spark Plug Recess Area, Replace Spark Plug and Ignition Coil, Seal Ign Coil Bolt Hole) - (May 12, 2009)

Subject: Malfunction Indicator Lamp (MIL) Illuminated, DTCs P0300-P0306, Engine Runs Rough (Inspect for Water Intrusion in Spark Plug Recess Area, Replace Spark Plug and Ignition Coil, Seal Ignition Coil Bolt Hole Vents and Seal Hood Air Grille)

Models: 2008-2009 Chevrolet Colorado, TrailBlazer
 2008-2009 GMC Canyon, Envoy
 2008-2009 HUMMER H3, H3T
 2008-2009 Saab 9-7X
 All Equipped With Engine RPOs LLR, LLV, LL8
 Please Refer to GMVIS

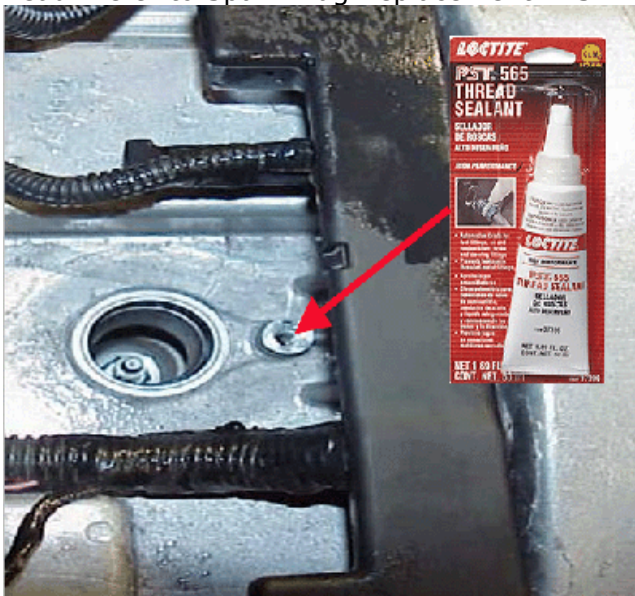
This condition may be caused by an engine being exposed to a large quantity of water, which may result in some of the water seeping down past the vented threads of an ignition coil bolt, then flowing through the vent opening that is located in the bottom of the related ignition coil bolt hole, and collecting in the spark plug recess area.

9. Fill the bottom of the ignition coil bolt hole vent with Loctite® 565 PST Thread Sealant* as indicated in the illustration, and apply it to the ignition coil bolt threads also.
10. Replace *ONLY* the affected ignition coil(s) with new ignition coil(s) as needed. Refer to Ignition Coil Replacement in SI.
11. Connect the engine wiring harness electrical connectors to the ignition coil(s). Refer to Ignition Coil Replacement in SI.
12. Replace the air cleaner resonator and outlet duct. Refer to Air Cleaner Resonator and Outlet Duct Replacement in SI.
13. Clear the DTCs with a scan tool.
