TECHNICAL INFORMATION

MODEL Range Rover 4.0/4.6	SUBJECT PRIDE - CHMSL Wiring Harness Repositioning	05/30/97 86/11/97/NAS
	AFFECTED VEHICLES LP 1995 up to TA334213 LH LJ LD

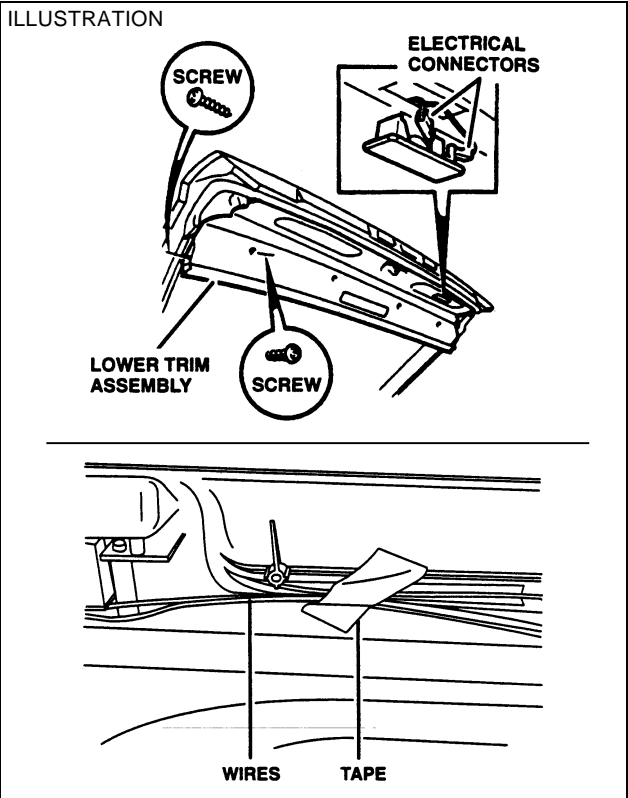
DETAIL
The wiring for the Center High Mount Stop Light (CHMSL) in the upper tailgate harness may be pinched by one of the screws that secures the panel shelf extension to the vehicle body. When this happens, the CHMSL shorts and blows Fuse 17. This results in a disabled shift interlock system and a vehicle that is stuck in PARK. Taping the CHMSL wires inside the trim piece away from the screw will prevent this from happening.

Cut an approximately two inch by one inch wide piece of masking tape and secure the wires away from the screw post as shown in the illustration.
