Vehicle	VAUXHALL / Vectra 2.5 i V6 / 09/1995 - 08/2001 / Notchback Saloon, Squareback/hatchback limousine
Country of manufacture	GB
Cubic capacity/Power	2.5 / 125 - 143 kW
Motor tag	X 25 XE
RB key	VAU 188

## Known fixes and bulletins

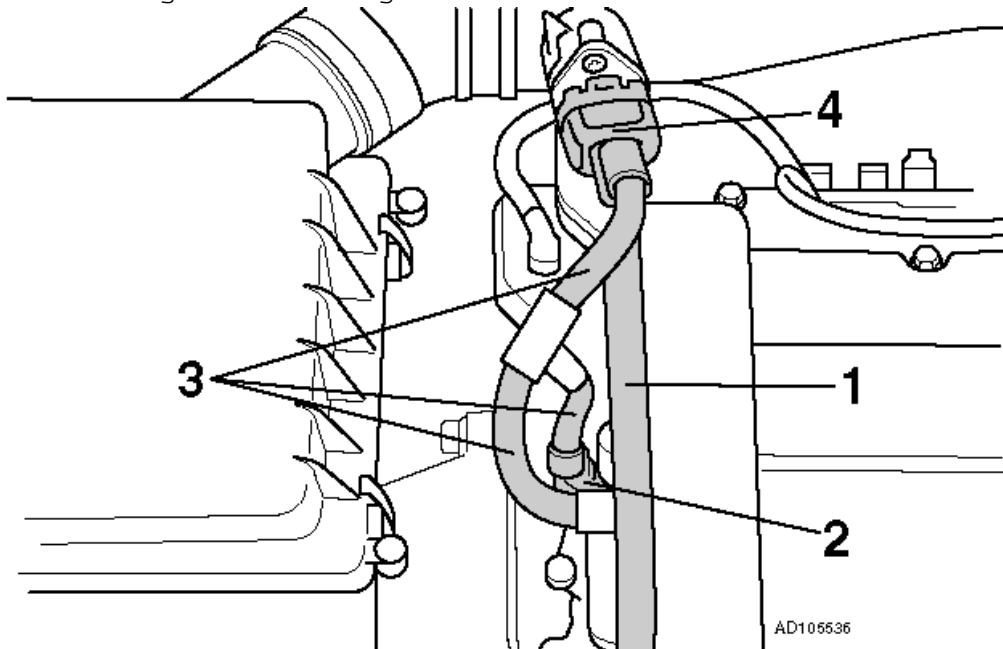
- Poor connection in engine coolant temperature (ECT) sensor harness multi-plug due to vibration.

- Disconnect battery.
- Disconnect harness multi-plug from engine coolant temperature (ECT) sensor Fig.1 [2] .
- Disconnect harness multi-plug from mass air flow (MAF) sensor Fig.1 [4] .
- Remove protective cover Fig.1 [1] .
- Remove plastic tube from wiring harness Fig.1 [3] . Remove insulation tape from wiring harness.
- Cut engine coolant temperature (ECT) sensor wiring and remove from cable ducting.
- Cut new engine coolant temperature (ECT) sensor wiring a minimum of 120 mm long.
- Fit new wiring harness multi-plug to wires Fig.2.
- Repair wiring with repair kit listed. Seal with insulation tape Fig.3.
- Remove engine coolant temperature (ECT) sensor.
- Fit modified engine coolant temperature (ECT) sensor. Tightening torque: 18 Nm.
- Refit wiring harness multi-plug. Reconnect battery. Erase fault memory.
